PROPERTY & LIABILITY INSPECTION

January 2012

**PREPARED FOR
San Bernardino Community College**

KEENAN & ASSOCIATES
3550 Vine St. Suite 200
Riverside Ca. 92507

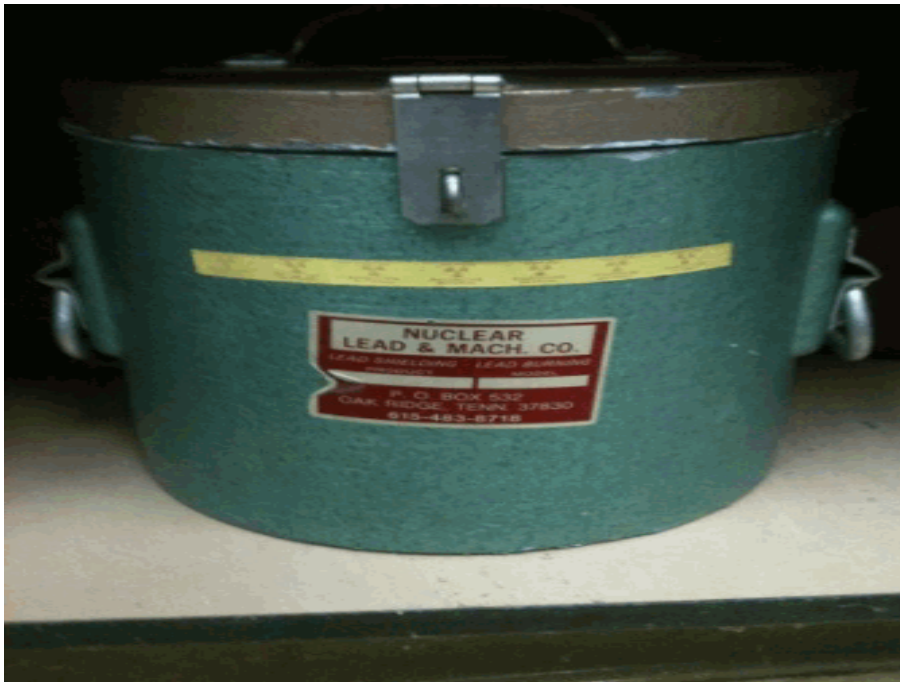
LADM 102 STOREROOM

A container marked 'RadioActive' is located in the Storeroom cabinet. This item needs to be tested and disposed of accordingly.

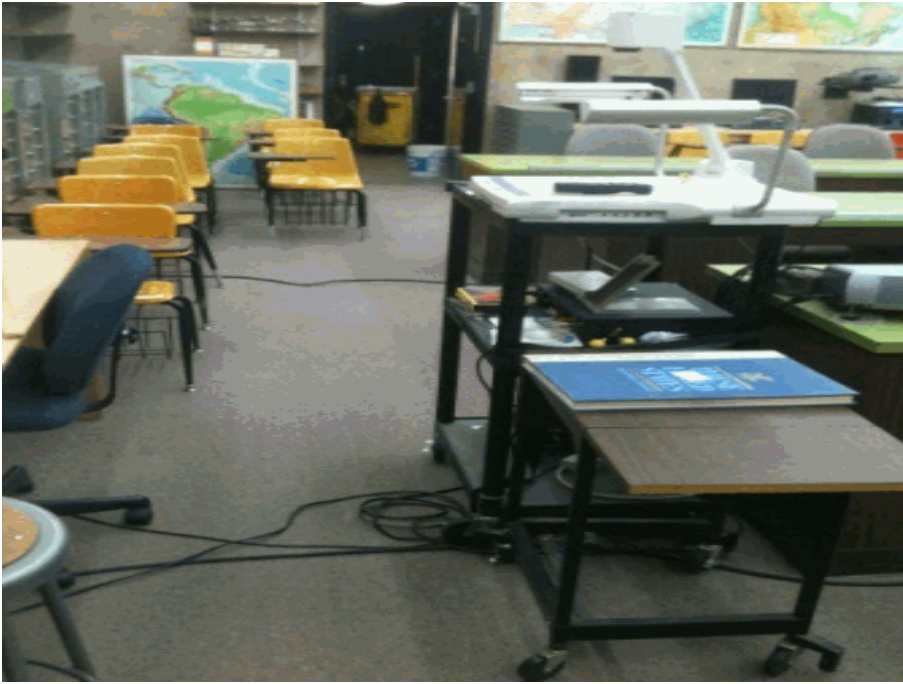
LADM 106 GEOLOGY

The location of electrical power cords created a trip/fall hazard. Cords should be routed away from walking areas or properly secured to eliminate hazard.

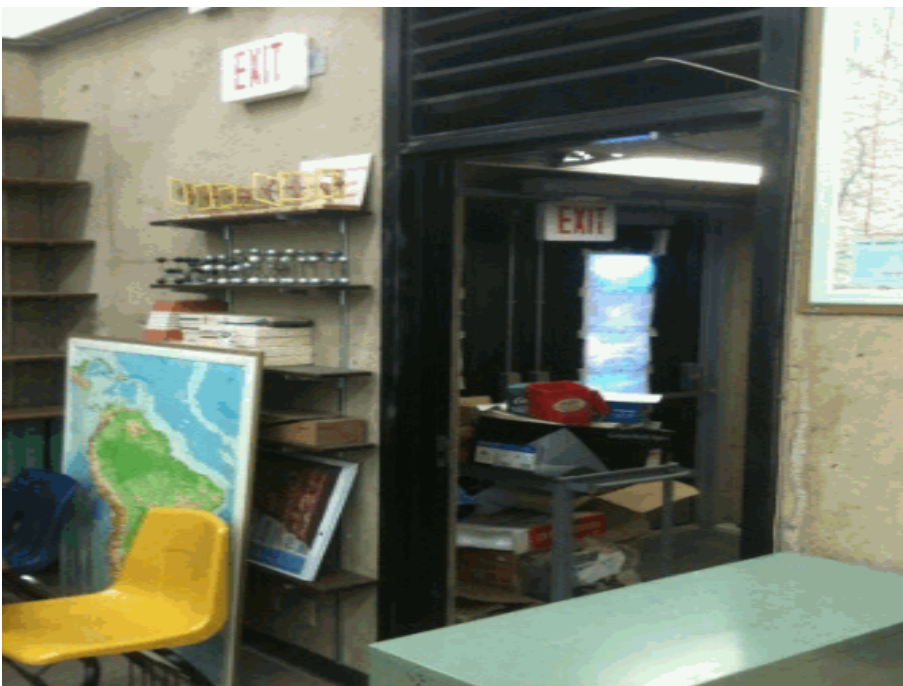
Exits and other elements of an emergency evacuation route must be kept clear at all times. Many exit doors and aisles were obstructed or partially obstructed. Doors that open to an exit pathway must not be propped or tied open.

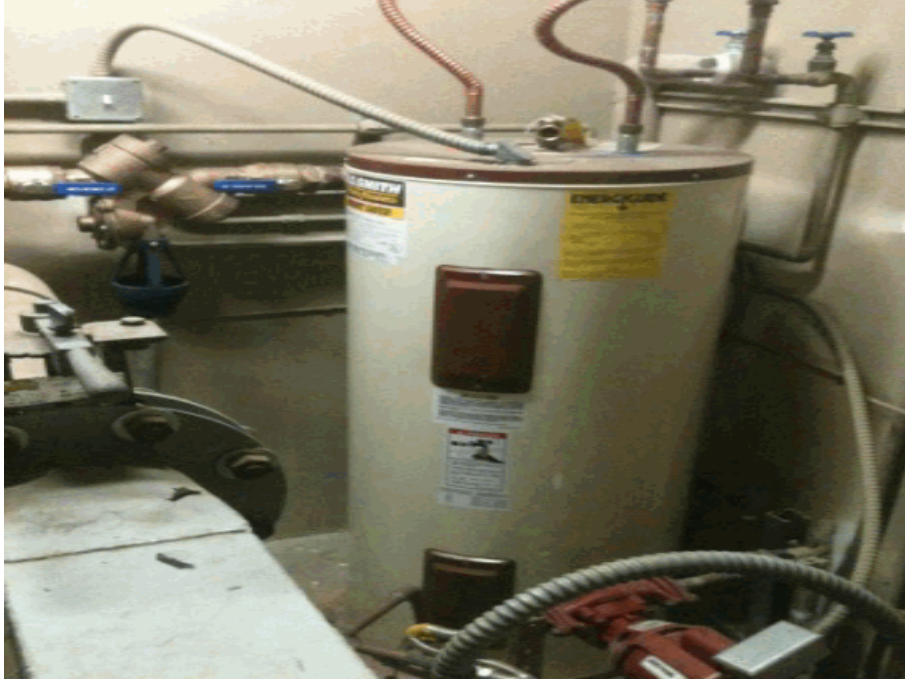
CRAFTON HILLS COLLEGE
LADM 243 MECH&ELEC RM

Water heaters should be strapped to the wall or bolted to the floor to prevent them from tipping over during seismic activity. Should they tip over, ruptured gas and water lines present severe fire and water damage hazards.

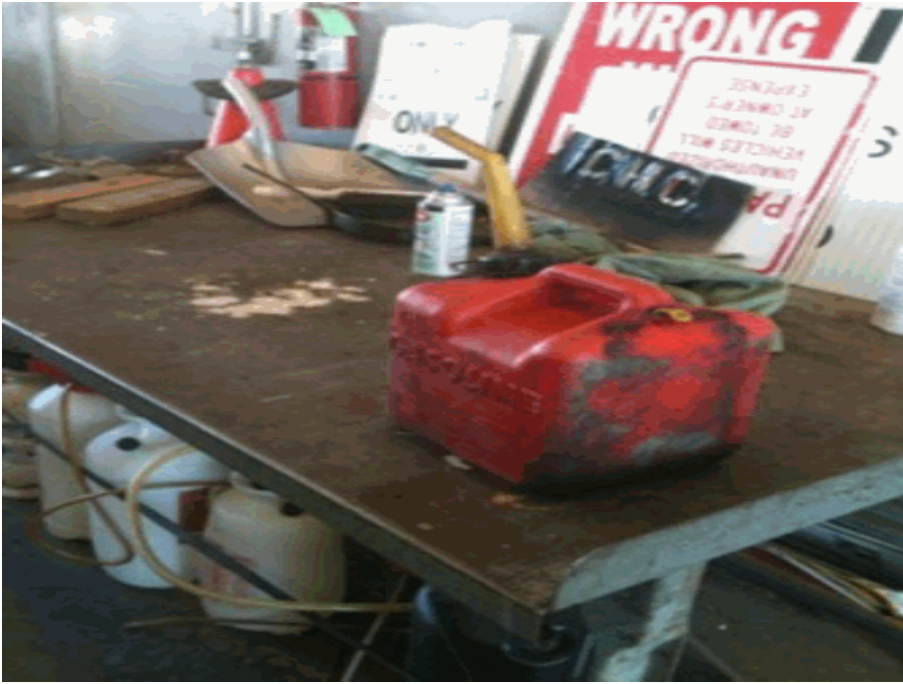
M&O GROUNDS

Flammable liquids should not be left out in general areas and potentially stored near sources of ignition such as gas-fired furnaces, water heaters or boiler units.

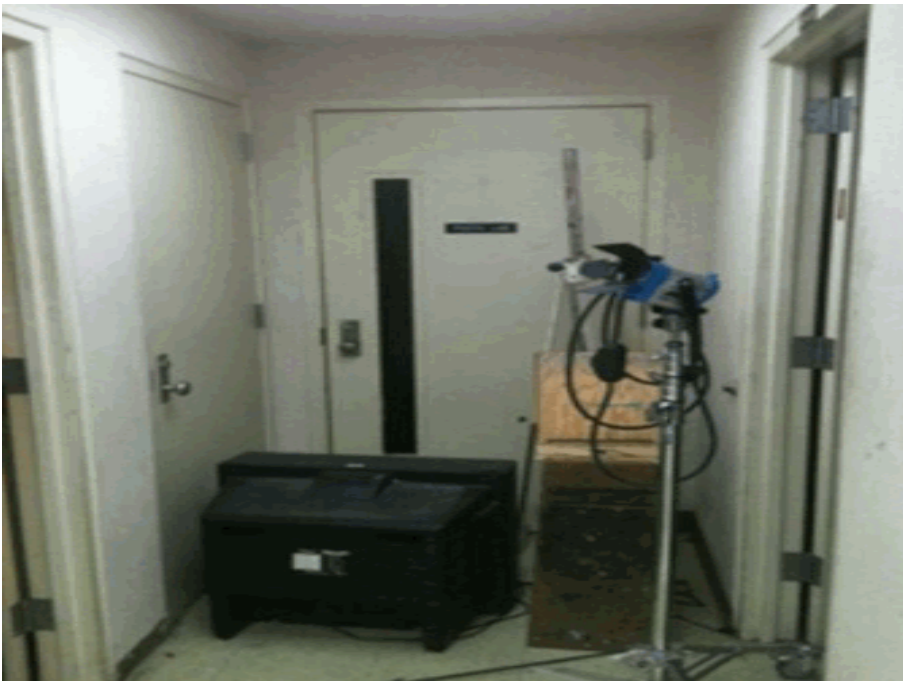
OE1 101 ACCESS/EGRESS

The Art Room only has one designated exit. A second passage door through to the EMS Labs is available to be used however, this passage way is blocked from both the Art Room and the EMS Lab side. Safe exiting aisles with a minimum width of 30" should be maintained from all parts of each room. This can be accomplished by re-arranging desks, removal of unused materials or furniture, or a combination of the above.

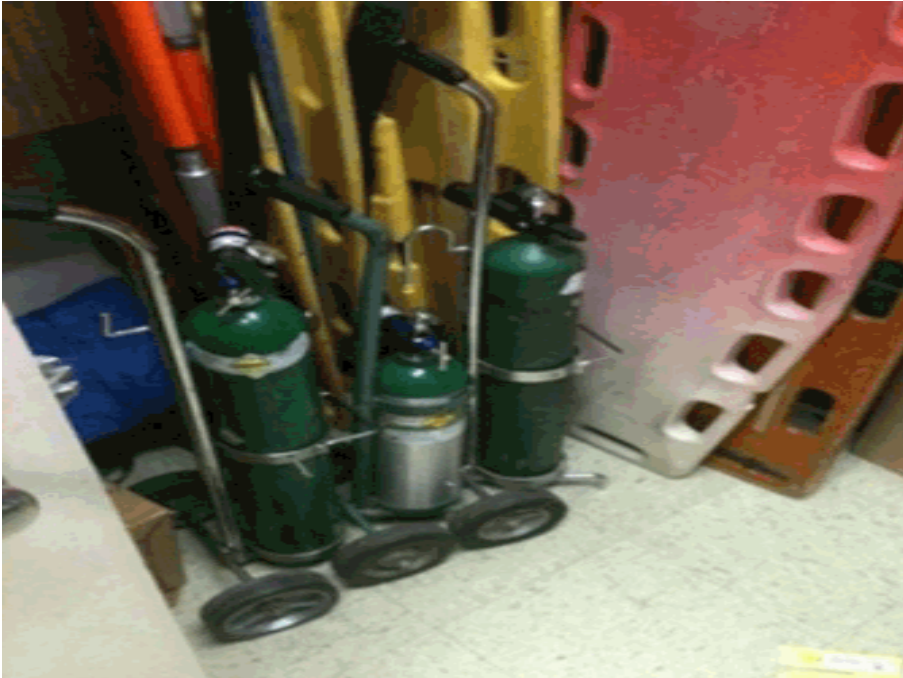
OE1 107 BLS CLOSET

NFPA sign to be supplied to identify the presence of Compressed Gas cylinders.

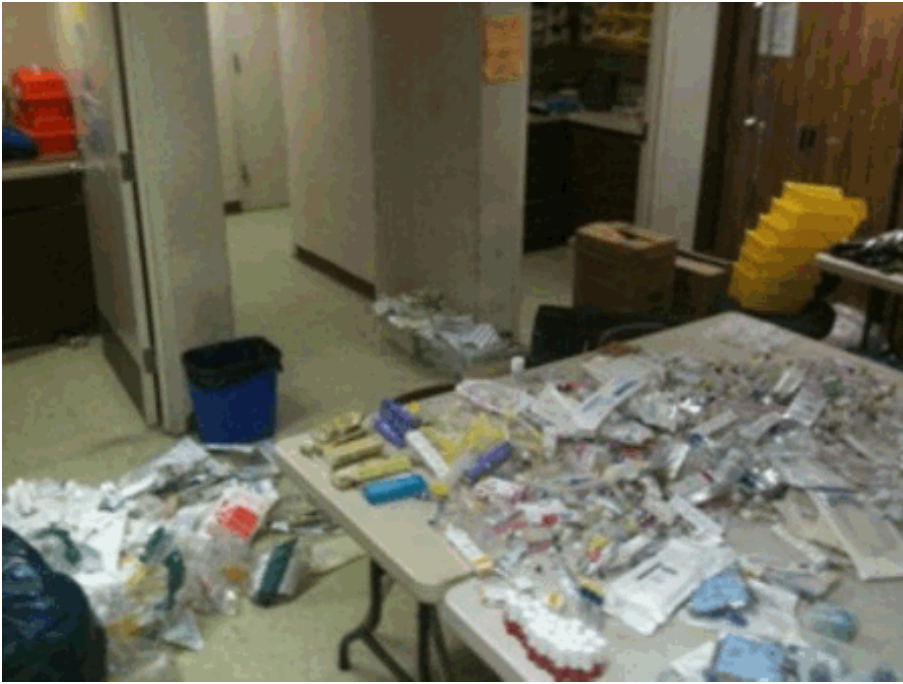
OE1 110 STOREROOM

Housekeeping should be improved. The area should be kept in a clean and orderly condition. Aisles and passageways should be kept clear and in good repair.

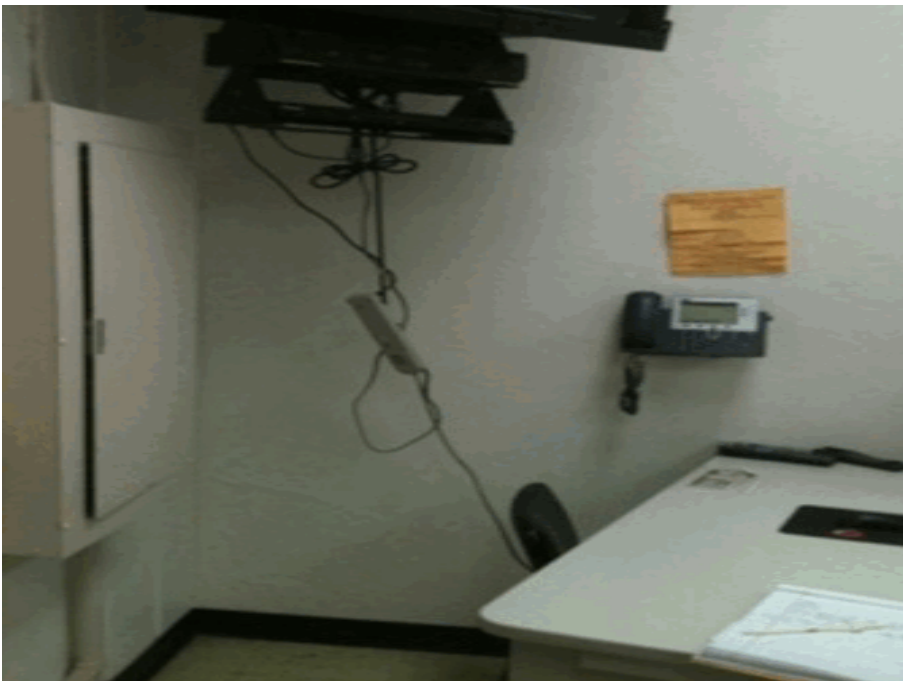
OE1 127

Extension cord loaded onto a second extension cord, potentially leading to overloading of the system.

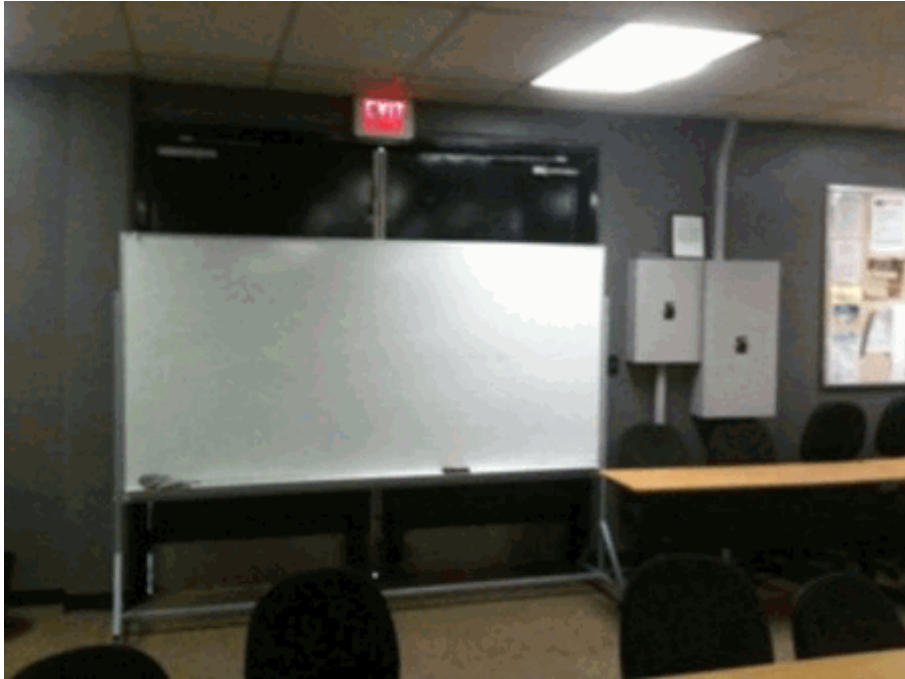
OE2 FIRE ACAD TRAINING RM

Exits and other elements of an emergency evacuation route must be kept clear at all times. Many exit doors and aisles were obstructed or partially obstructed. Doors that open to an exit pathway must not be propped or tied open.

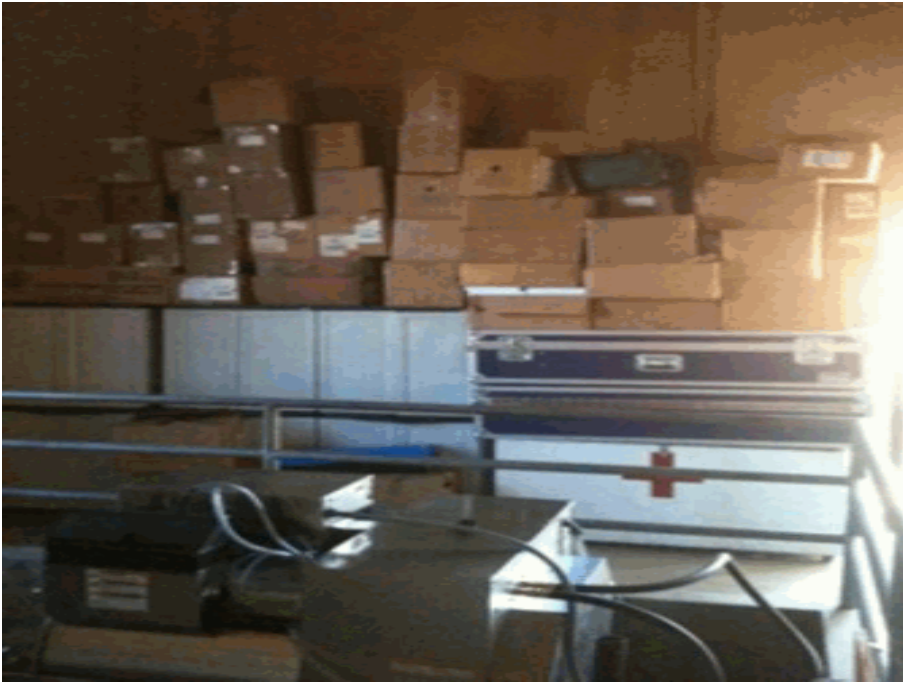
OE2 LAUNDRY PIT

Housekeeping should be improved. The area should be kept in a clean and orderly condition. Items should be stored on secure shelving.

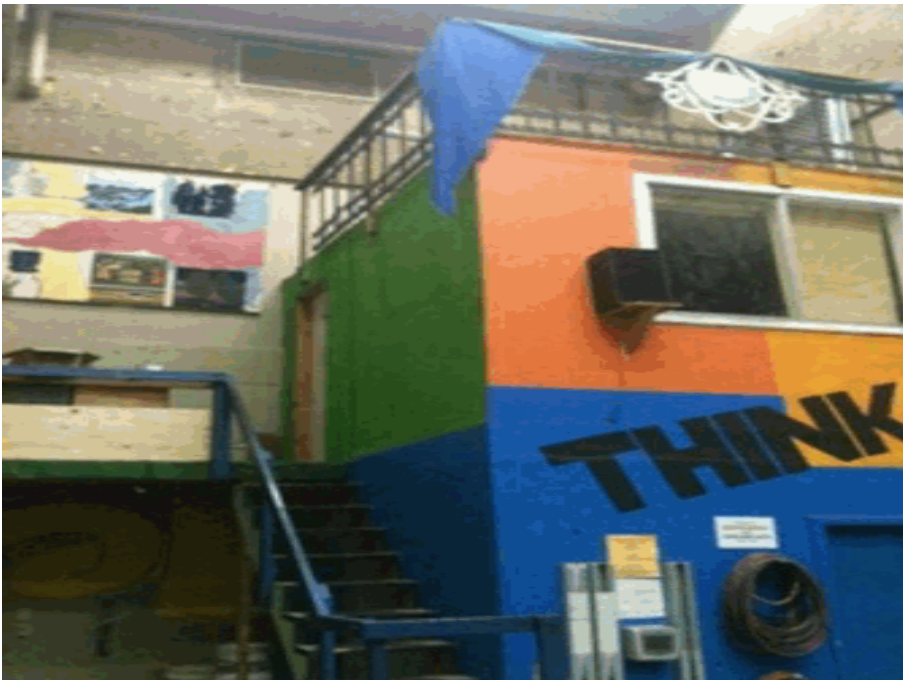
PAC THEATER WORKSHOP

High level storage of goods on a non approved storage area. No safe access has been supplied and no proof is available stating that the structure could withhold heavy items during storage.

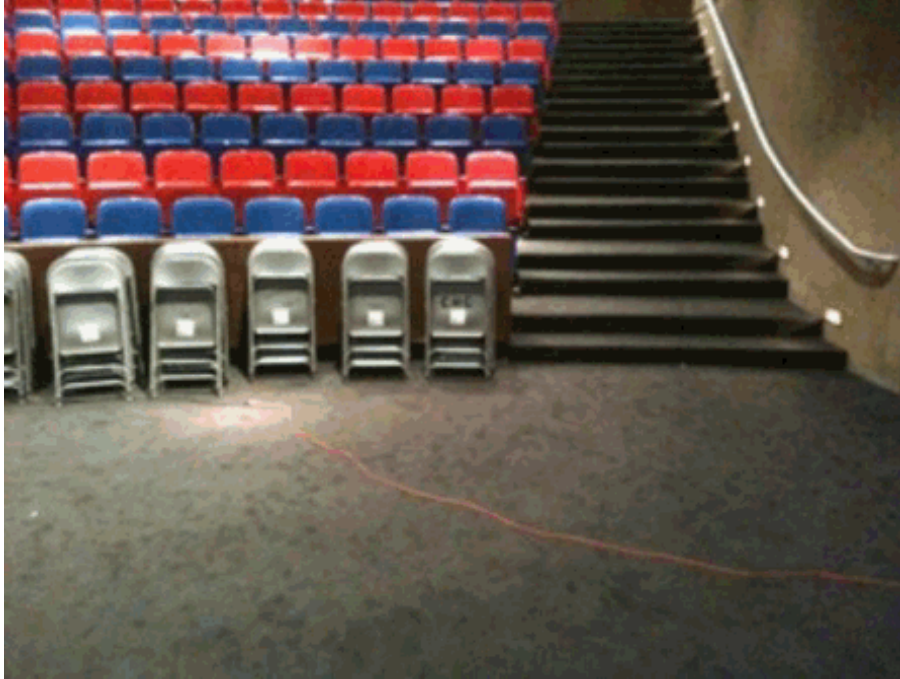
CRAFTON HILLS COLLEGE PAC THEATRE

The location of electrical power cords created a trip/fall hazard. Cords should be routed away from walking areas or properly secured to eliminate hazard.

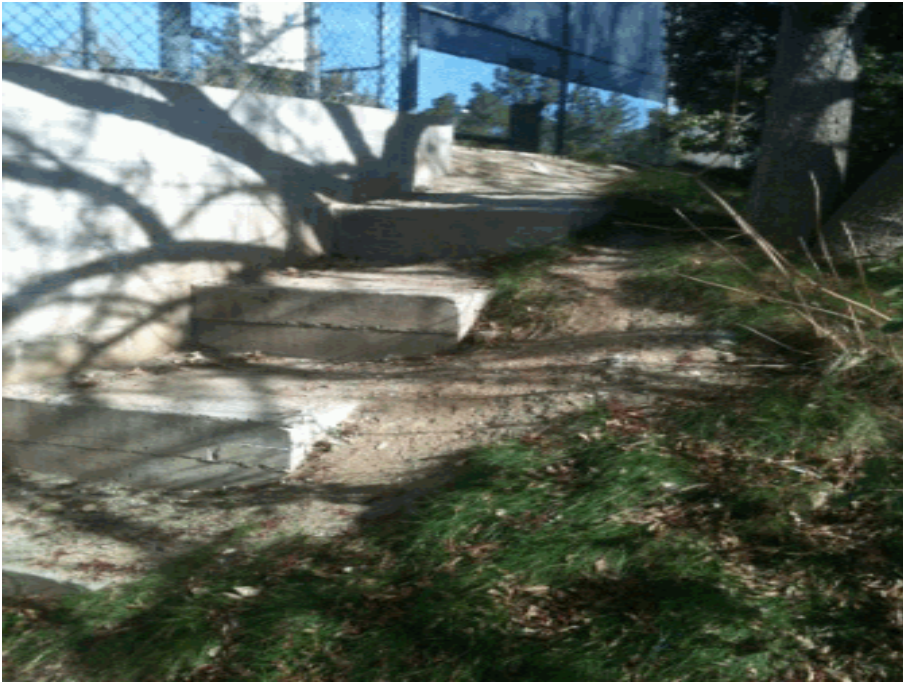
TENNIS COURTS - ACCESS PATH

The raised section of the sidewalk created trip and fall hazards; therefore, ground repairs should be made in order to eliminate the hazard observed.

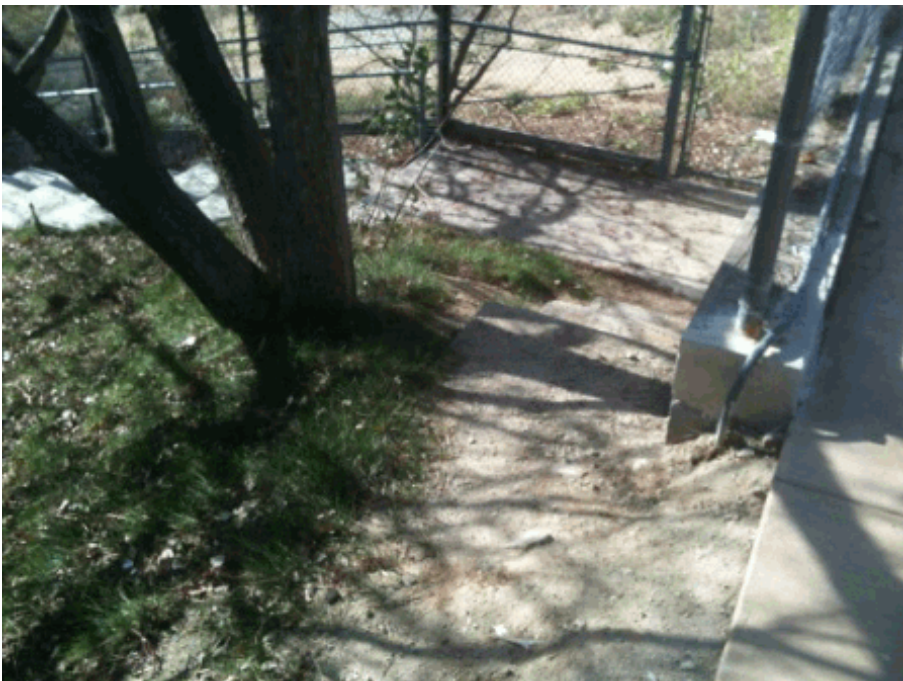
Unkept steep steps are being covered with loose gravel, leading to potential slips and falls.

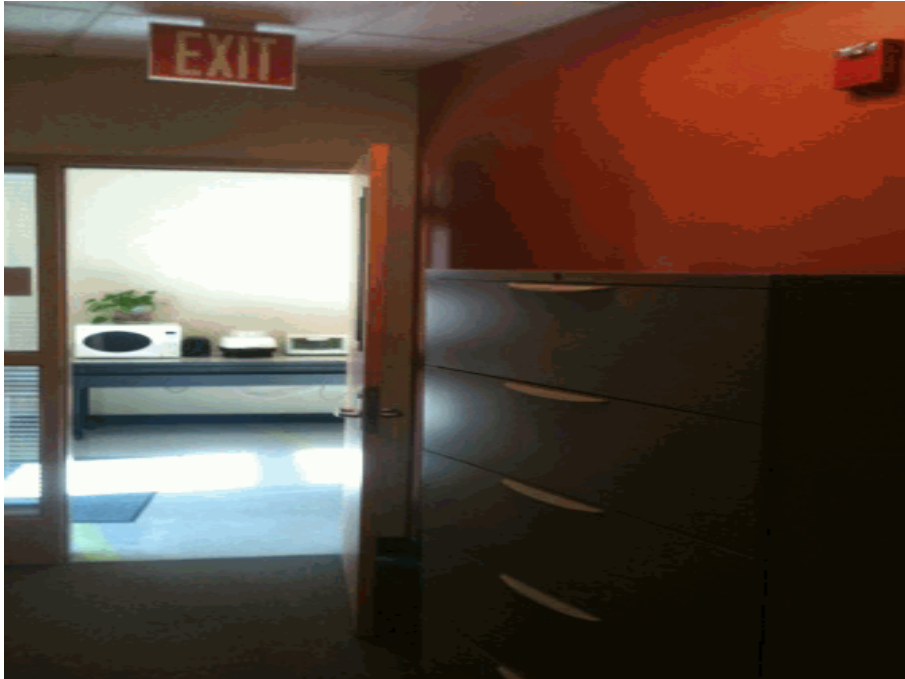
ATTC HALLWAY 108

Bookcases and storage cabinets should be secured to the wall, the floor or each other, or located so as to prevent them from tipping over and/or striking persons in the room.

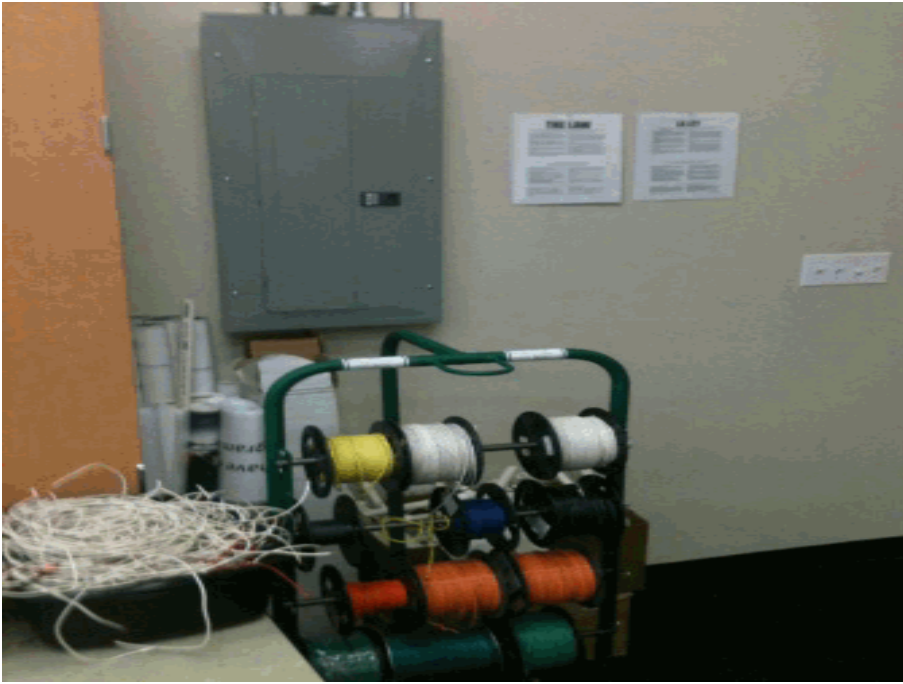
ATTC RM 121

The electrical panel was blocked by miscellaneous material. A minimum 36" clearance should be maintained around the panel at all times.

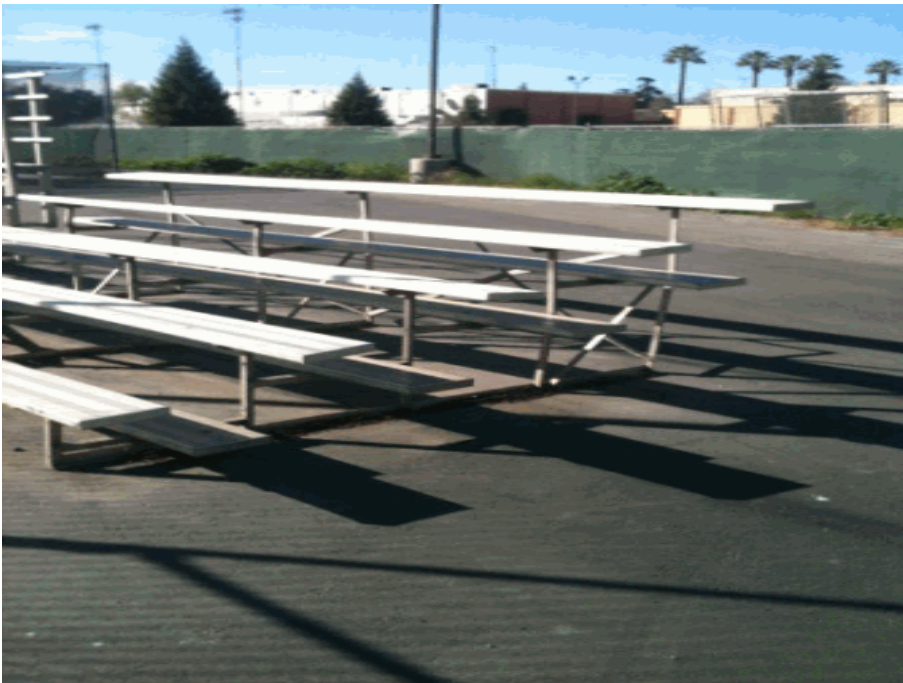
SAN BERNARDINO COLLEGE
BASEBALL FIELD BLEACHERS

The bleachers should be provided with side railings from the third row and above and a back railing across the back of the top row.

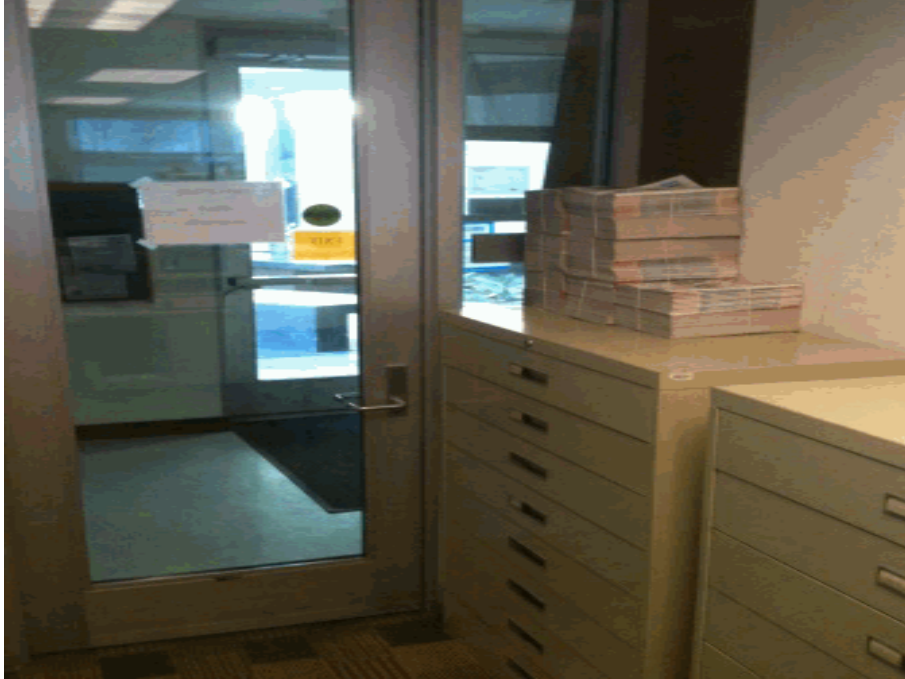
BLDG. AD SS 100 RM

Bookcases and storage cabinets should be secured to the wall, the floor or each other, or located so as to prevent them from tipping over and/or striking persons in the room.

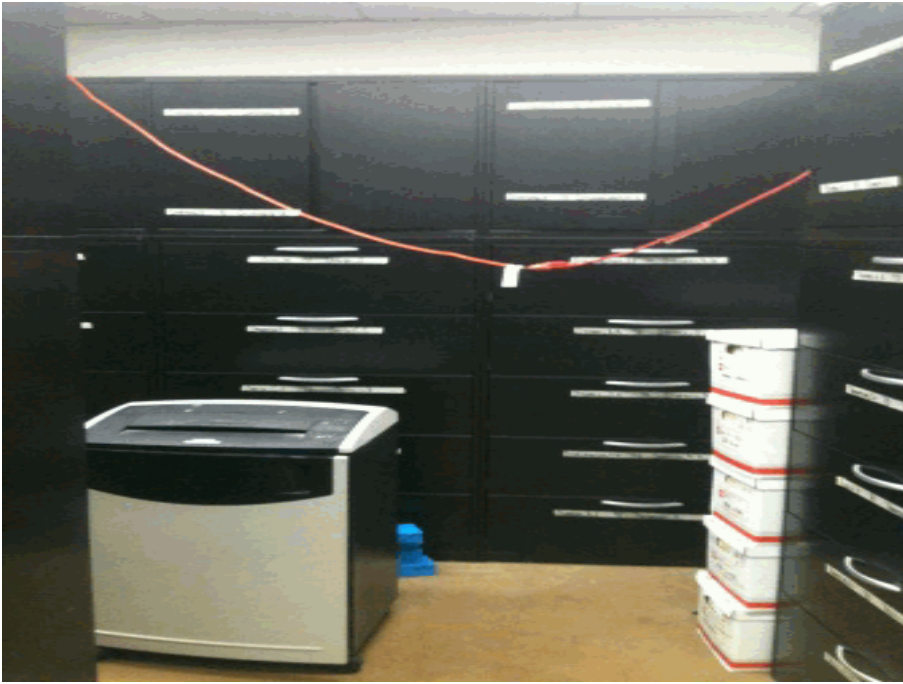
BLDG. AD SS 100C RM

Electric extension cords installed for permanent use should be replaced with permanent wiring in accordance with the National Electric Code.

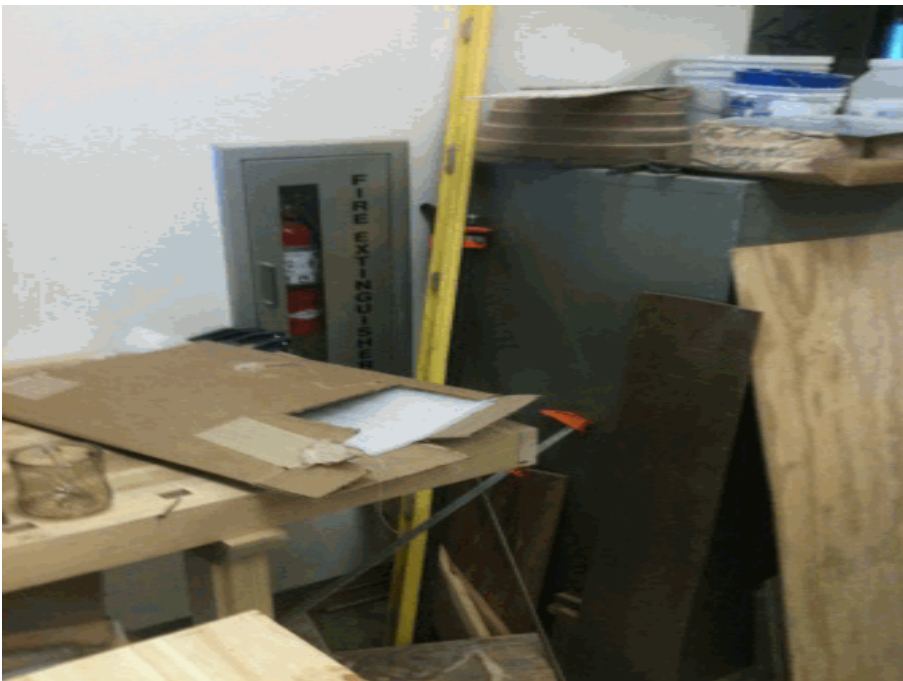
BLDG. ART 119 WORKRM

Access to the fire extinguisher was blocked or obstructed. Access must be kept clear at all times.

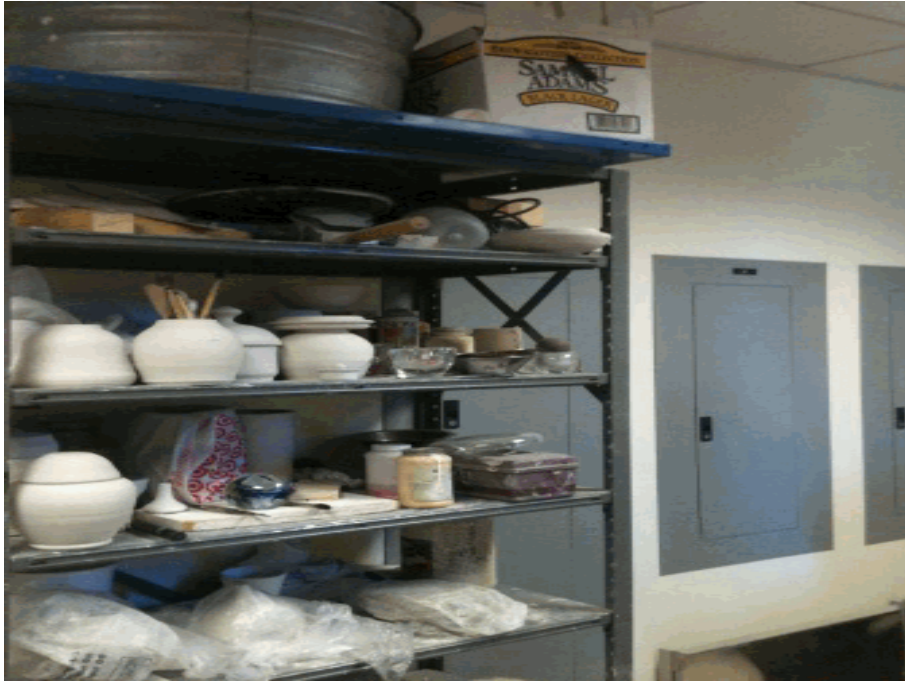
BLDG. ART 124 STORAGE

Unsecured high level equipment and materials must be removed and stored at a lower level to prevent accidental injury through falling items.

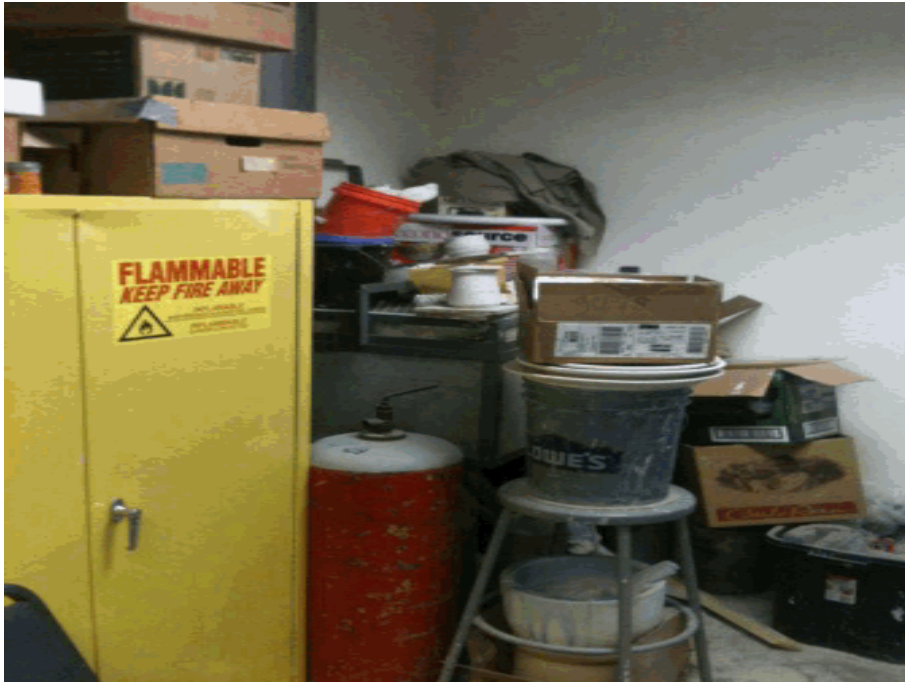
Housekeeping should be improved. The area should be kept in a clean and orderly condition. Aisles and passageways should be kept clear and in good repair.

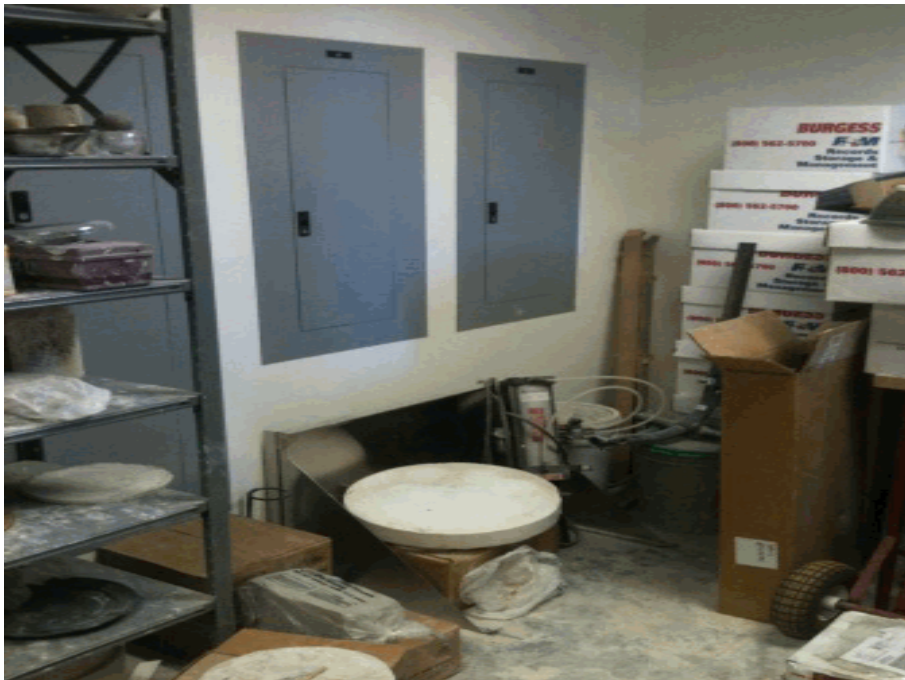
The electrical panel was blocked by miscellaneous material. A minimum 36" clearance should be maintained around the panel at all times.

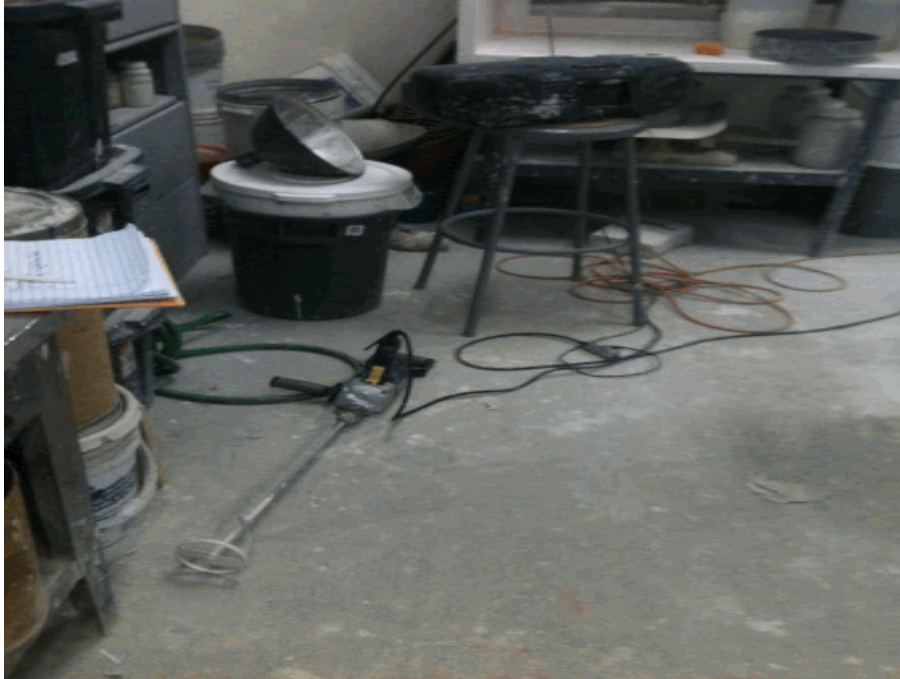
BLDG. ART 129 GLAZE RM

Electrical equipment left plugged in, on the floor unattended. All electrical equipment not used, must be unplugged and stored away, especially in an area where water could possibly be present.

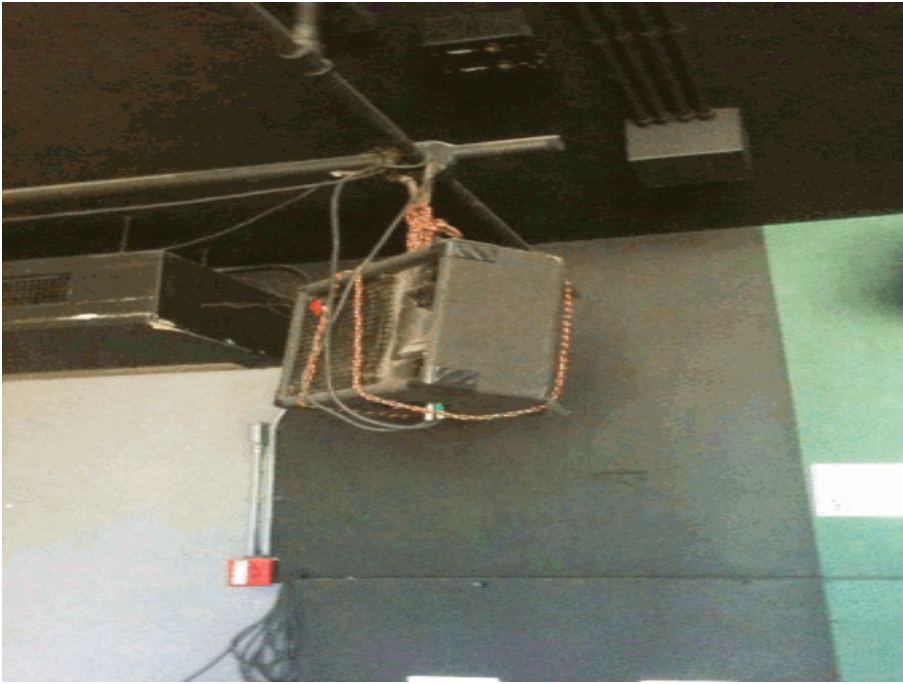
BLDG. AUD 2 BLACK RM

Overhead speaker system not correctly and safely secured. An elasticated bunji cord has been used to secure the unit. This needs to be replaced immediately with the correct kind of clamps and tie cords.

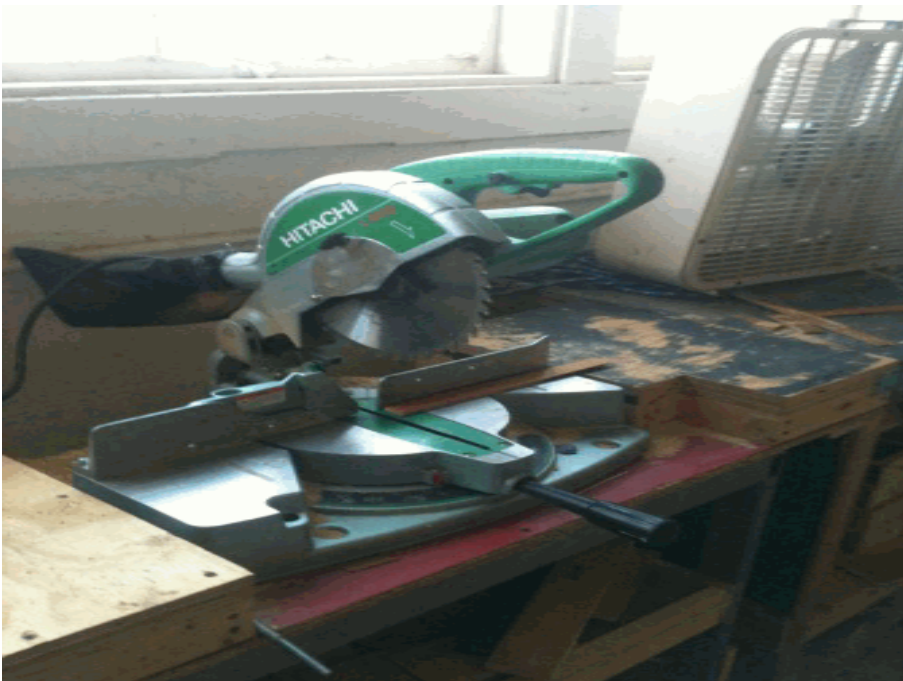
BLDG. AUD 4 SCENE RM

The blade guard on the table saw was missing and should be replaced.

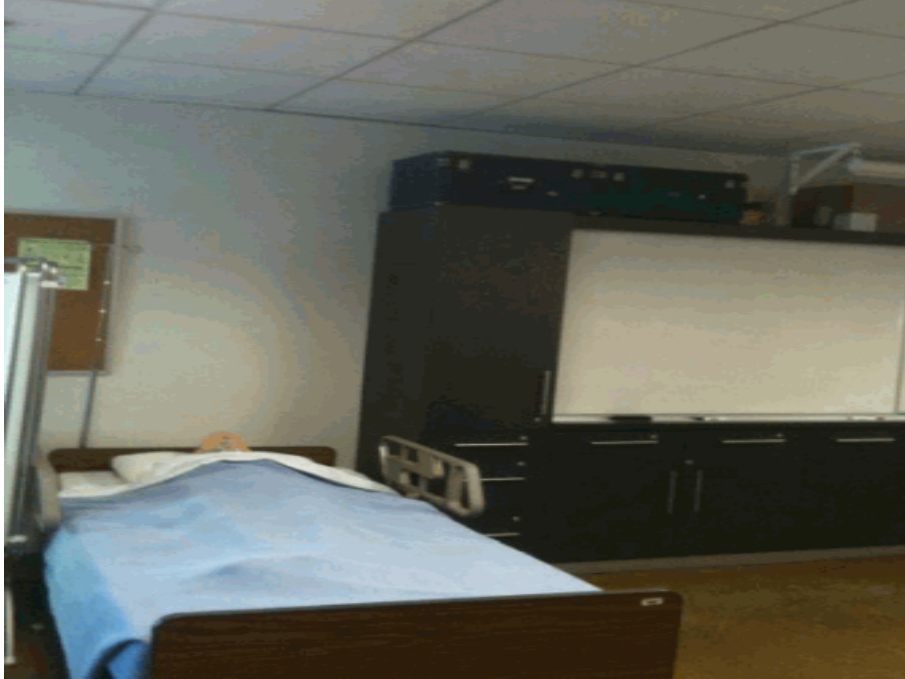
BLDG. HLS 131

Large and/or heavy items were stored overhead without being adequately secured. Items must be secured to prevent falling object hazards.

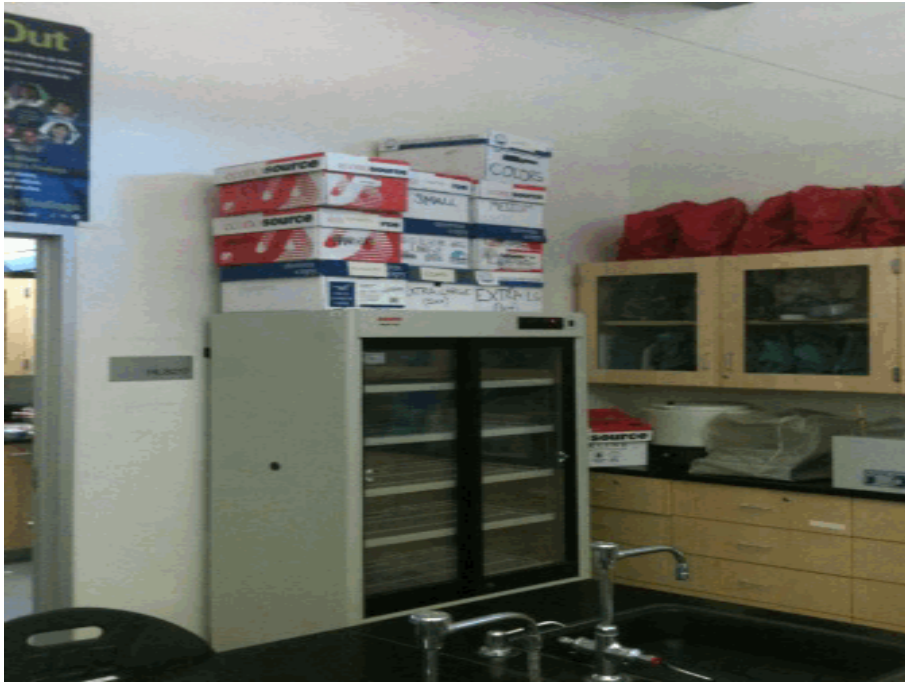
BLDG. HLS 218

Housekeeping should be improved. The area should be kept in a clean and orderly condition. High level storage not secured must be removed and stored at low levels to prevent items from falling from height and injuring someone.

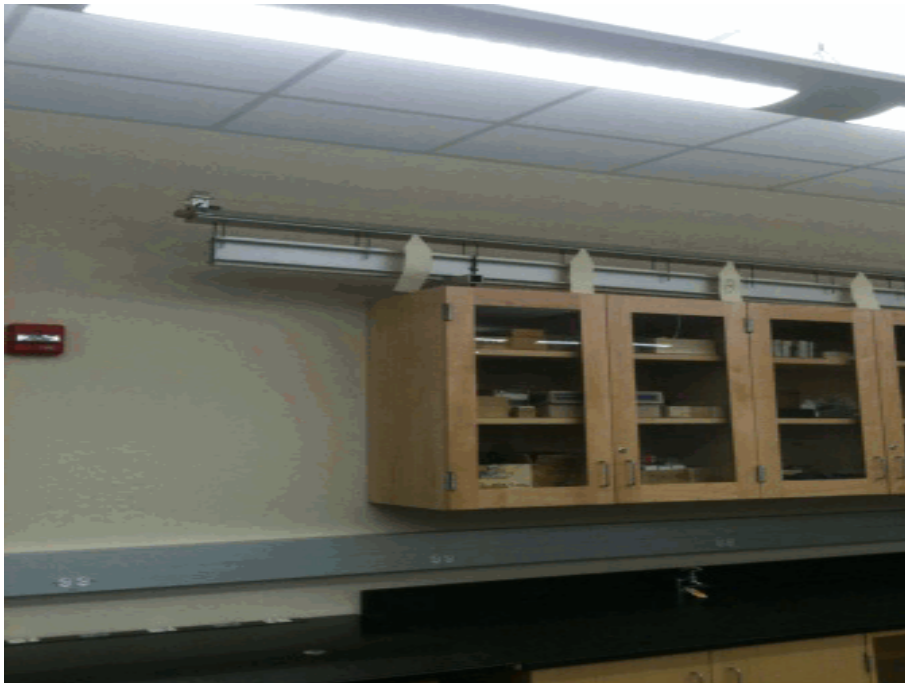
BLDG. PS 209

Large high level items need to either be secured or removed from height where it could potentially fall and injure someone.

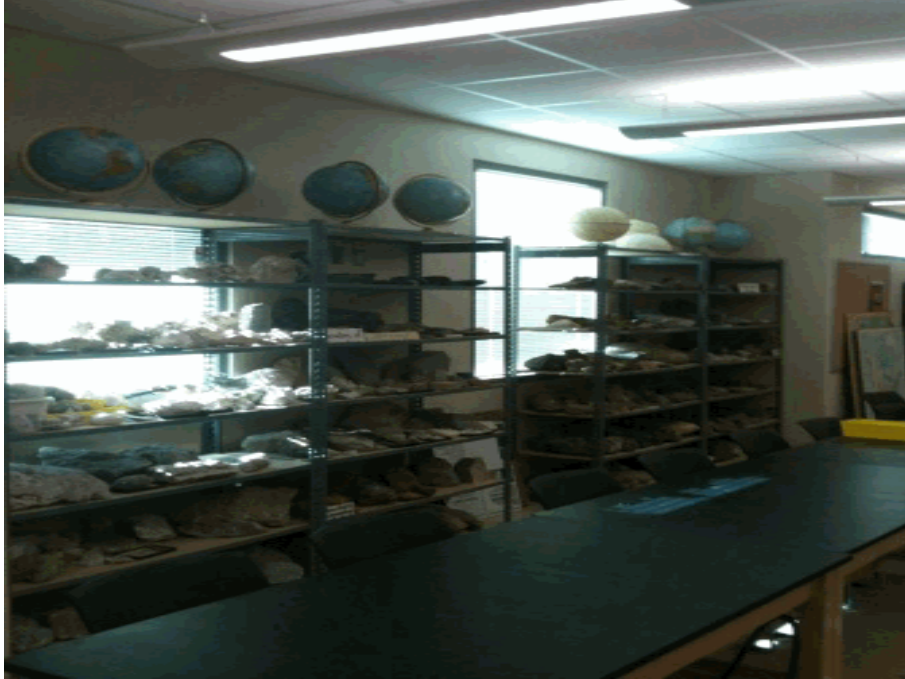
BLDG. PS 219

Bookcases and storage cabinets should be secured to the wall, the floor or each other, or located so as to prevent them from tipping over and/or striking persons in the room.

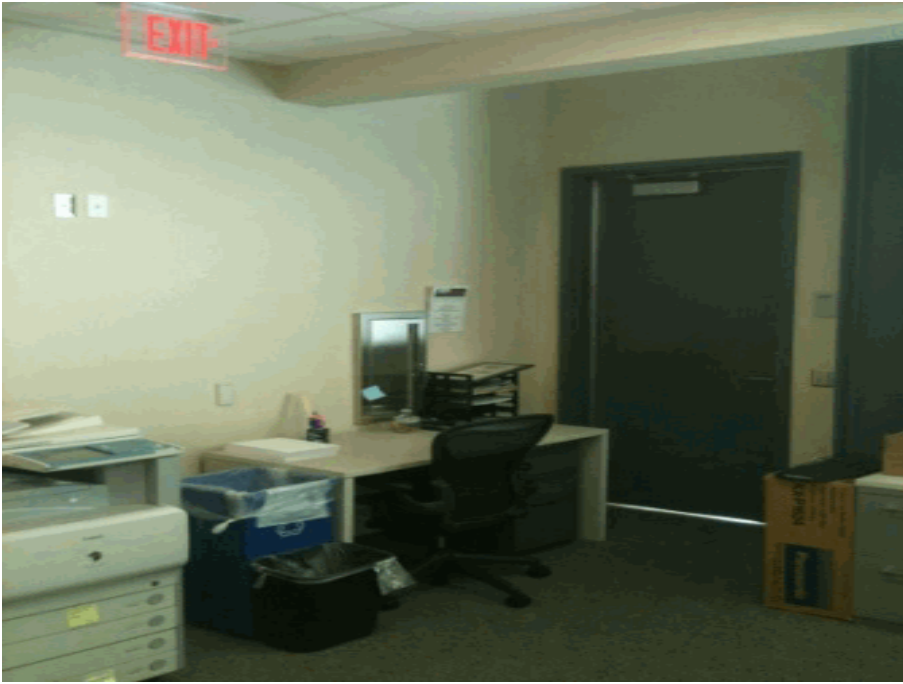
MEDIA CENTER - ADMIN

The table and equipment obstructing the exit should be removed and clear access maintained at all times.

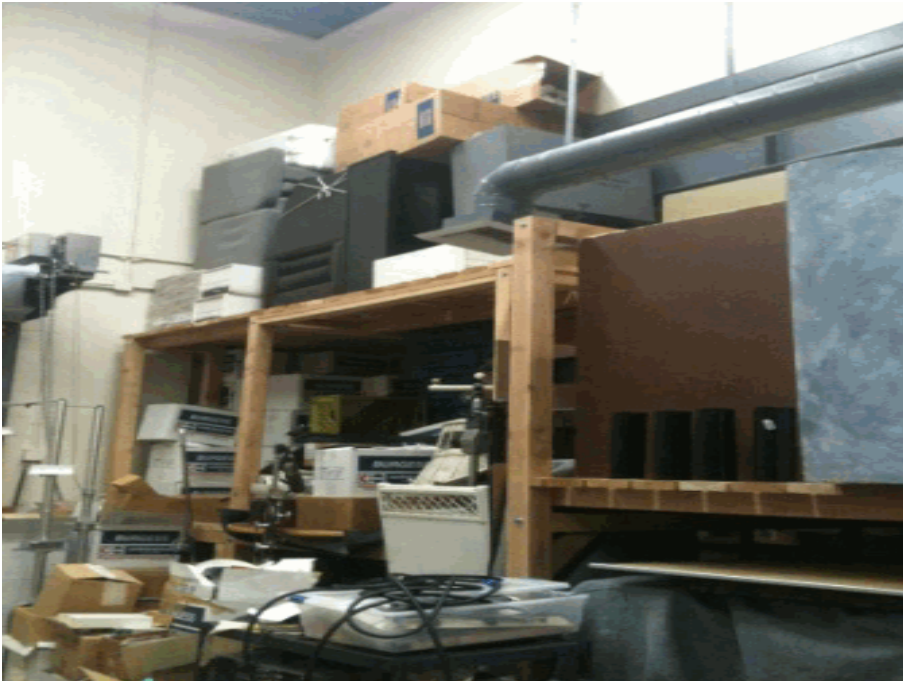
MEDIA CENTER - WAREHOUSE

The weight/load rating is not posted on the pallet racks. The rating should be determined by a competent person and clearly posted.

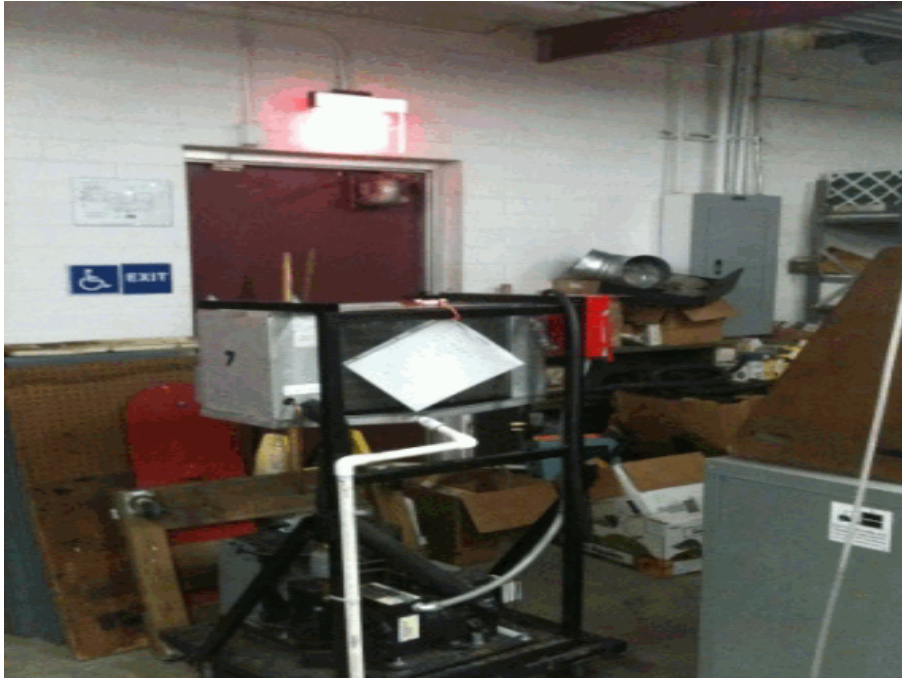
The equipment obstructing the exit should be removed and clear access maintained at all times.
