PROPERTY & LIABILITY INSPECTION

January 2012

**PREPARED FOR
San Bernardino Community College**

KEENAN & ASSOCIATES
3550 Vine St. Suite 200
Riverside Ca. 92507

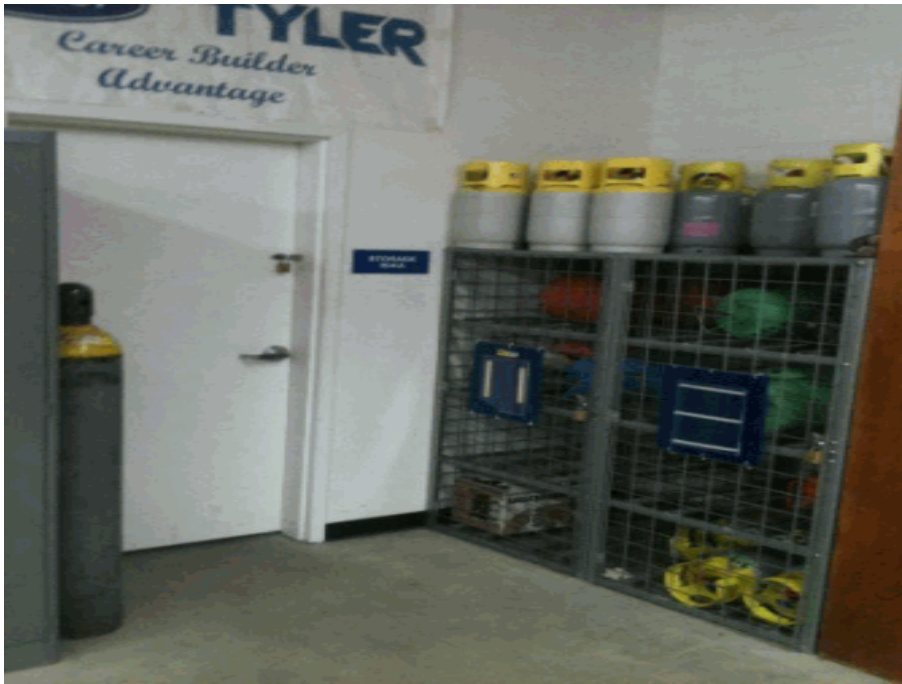
All compressed propane cylinders should be secured in the upright position with strong securing devices (chain, straps or clamps) to prevent accidental tip-over and fall off the cage.

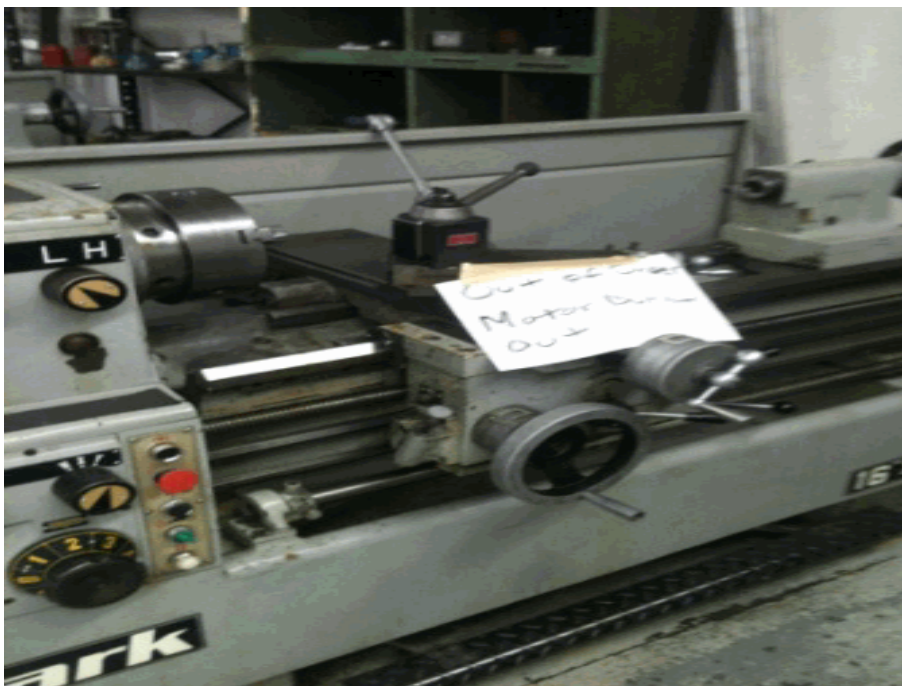
T BLDG 111 MACHINE SHOP

Lack of evidence of a good Lock out / Tag out program. A simple piece of paper is being used to ensure a faulty machine is not used. This is an insufficient way of ensuring the equipment is not used. The machine must be electrically disconnected to ensure no one accidentally starts the faulty equipment up.

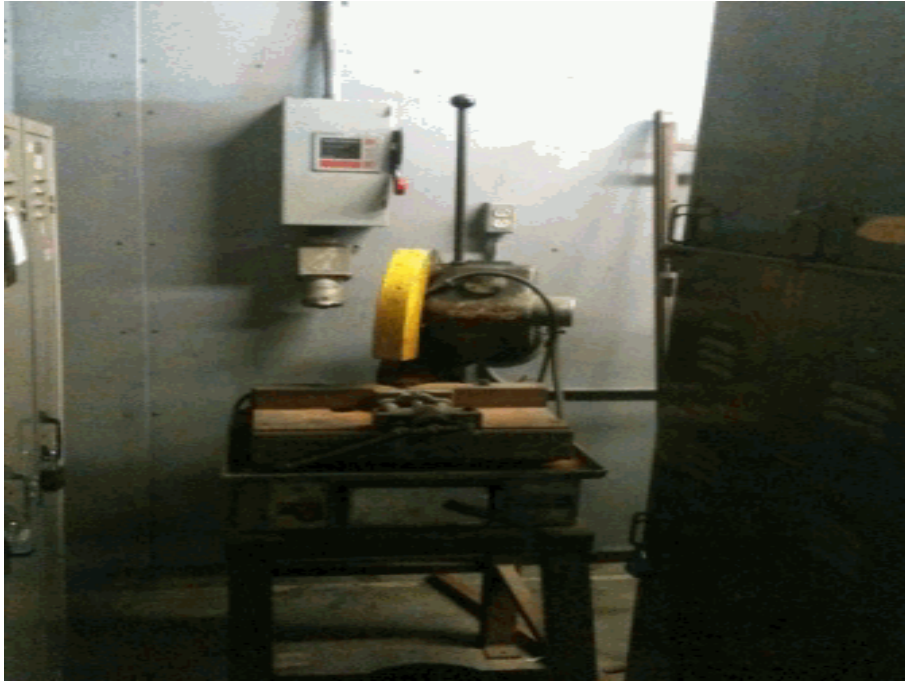
The electrical panel was blocked by miscellaneous material. A minimum 36" clearance should be maintained around the panel at all times.

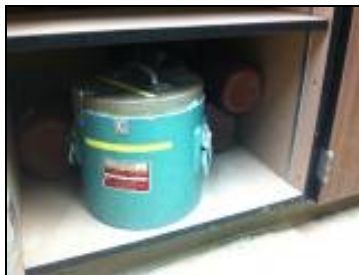
LADM 102 Storeroom

2. A container marked 'Radioactive' is located in the storeroom cabinet. This item needs to be tested and disposed of accordingly.

Issue still open – the container is still located in the storeroom cabinet.

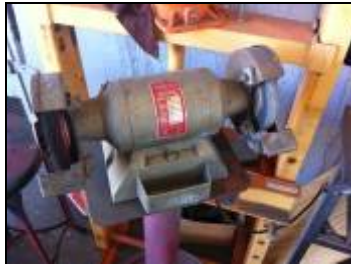
1. **Bench Grinder** – All grinders should be inspected and repaired/adjusted to meet the following requirements: a) tongue guards attached and kept adjusted to within 1/4” of the grinding wheel, b) tool rests attached and kept adjusted to within 1/8” of the grinding wheel, c) safety shields over the grinding wheels/brushes, d) safety shields equipped with lights should have bulbs in place.
