March 15, 2013

## San Bernardino Valley College - Tech Building

### MEP Systems Assessment and Recommendations

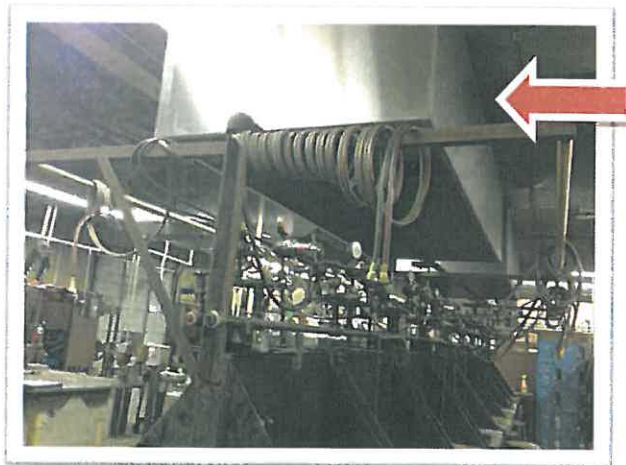
The welding shop is served by multiple exhaust fans, up blast and utility type, serving general exhaust, canopy exhaust hoods, and local exhaust snorkels. Supply air is provided via swamp coolers. The room also includes multiple space heaters to maintain the minimum space temperature required by the 2010 California Mechanical Code (CMC). The exhaust hoods are currently installed as updraft and pose a potential risk to students by putting them in direct exposure to the byproducts of the welding process. The use of downdraft hoods is recommended for the safety of students.

Figure M-1 - Updraft Exhaust Hood in Welding Shop 112B

- Welding Shops 112B and 121 include updraft capture hoods which poses a potential **life safety risk** to students. The use of downdraft hood is recommended for the safety of students. The existing updraft hoods shall be replaced with equivalent downdraft hoods and the ducting shall be modified to accommodate the new hoods.

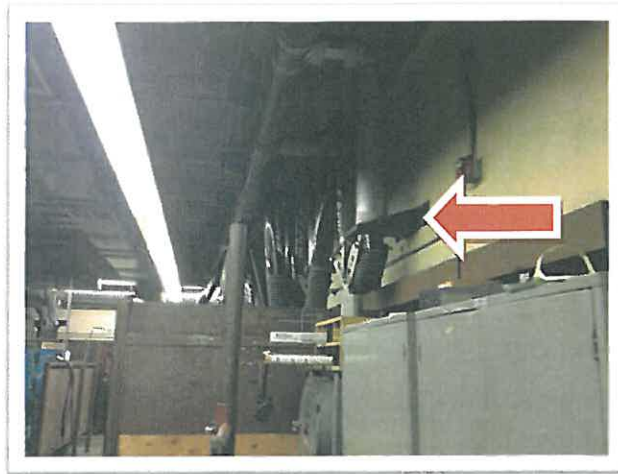
Figure M-2 - Local Exhaust Snorkels in Welding Shop 112B

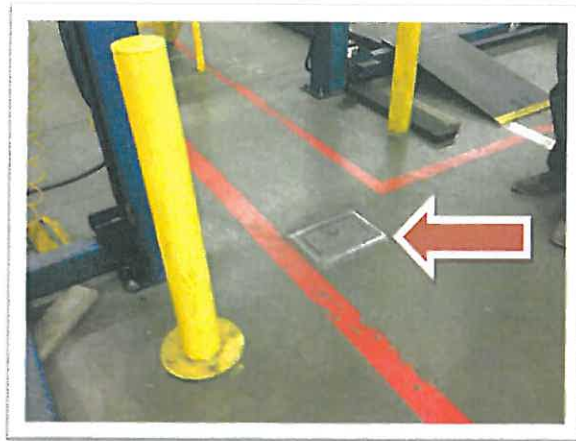
Figure M-3 - Underground Local Exhaust Connection in Auto Shop 116

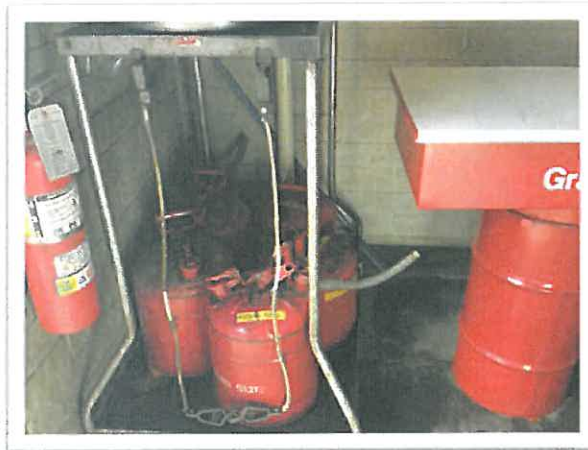
off position unless an occupant is in the building. Per NFPA 30-18.6, liquid fuel storage areas shall be provided with either a gravity system or a continuous mechanical exhaust ventilation system. As the current system is non-continuously mechanical exhaust ventilation, it does not meet NFPA 30 and is in violation of the code. Also, NFPA 30-18.6 requires a minimum of 1 CFM/SF for liquid fuel storage areas. The existing exhaust fans need to be verified to be a minimum of 1 CFM/SF for these spaces.

Figure M-4 - Fuel Storage Room 25

- AR1. The Fuel Storage Room in the yard is not equipped with constant ventilation as required by code. The existing fan controls shall be modified to provide a constant rate of air flow as required by code.
- Preliminary ROM: \$3,600**
- AR2. The Aeronautics Shop does not have proper ventilation. This was immediately evident during the field investigation as the space was high in temperature and stuffy even though outside conditions were very mild. It is recommended that a large roof top exhaust fan be installed so that the minimum ventilation requirements for this type of space are met. This shall include structural reinforcing and new ducting for the system.
- Preliminary ROM: \$17,300**

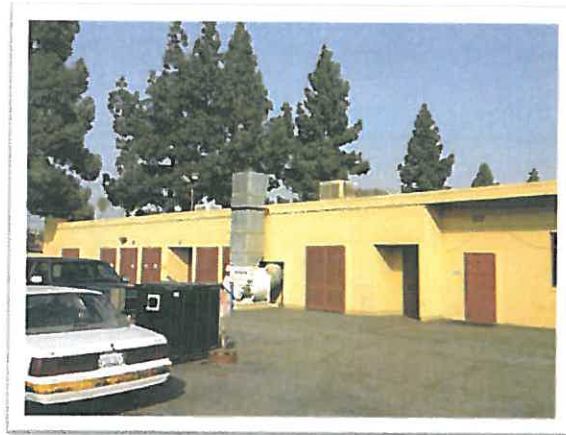
Figure M-5 - Exterior View of Welding 121 and Welding 12

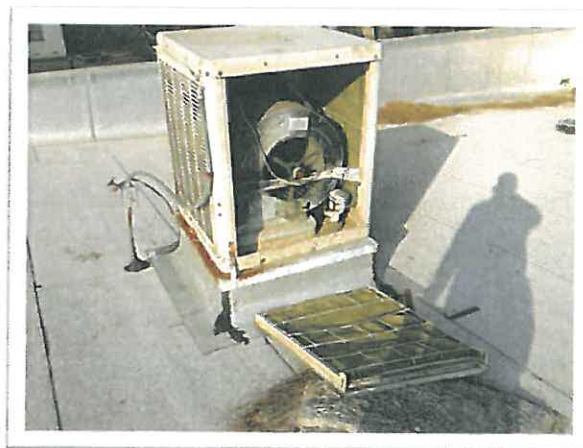
- A majority of the swamp coolers on the roof are either in the off position or not in an operable condition. In addition, all swamp coolers have reached their useful life. In order for the building to be able to provide ventilation and cooling, all (11) swamp coolers shall be replaced in kind. For reference, the current units are Champion Cooling Corporation Model 4300DD.

Figure M-6 – Condition of Existing Swamp Coolers

- GE1. Most of the swamp coolers on the roof are not operable. The remainder of the swamp coolers has reached their expected life. It is recommended that all eleven (11) swamp coolers be replaced to provide properly conditioned air to the various lab spaces.
- Preliminary ROM: \$58,000**

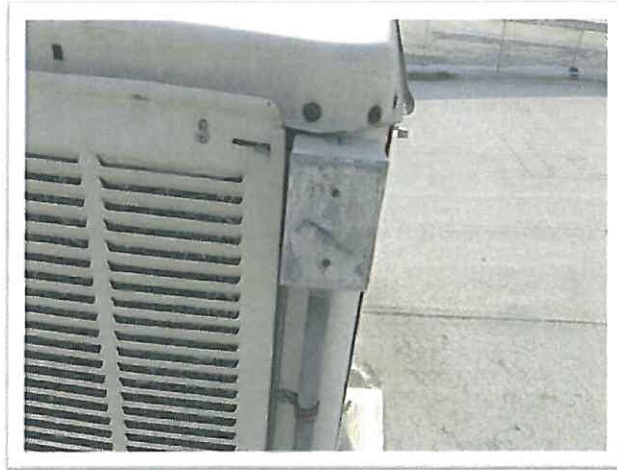
Figure M-7 – Swamp Coolers in the Off Position

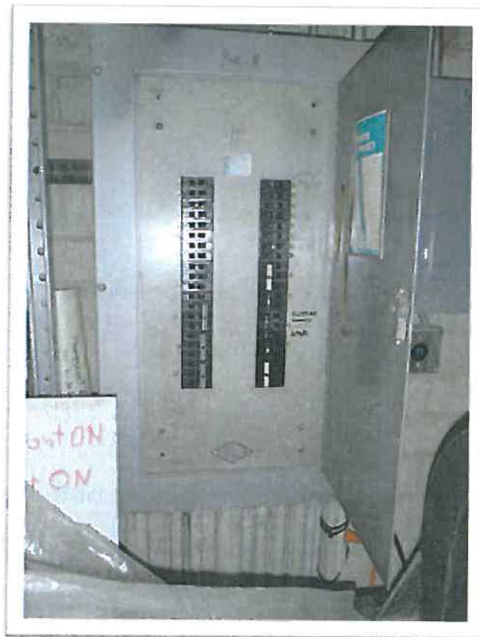
Electrical panels are located throughout the building to serve the needs of the facility. Many of the existing electrical panels, located in areas that have not been upgraded, were manufactured by Zinsco. Zinsco went out of business in the mid-1970s, and new replacement parts are no longer available. Refurbished circuit breakers are available, but are costly and difficult to obtain.

Typical Zinsco electrical panel

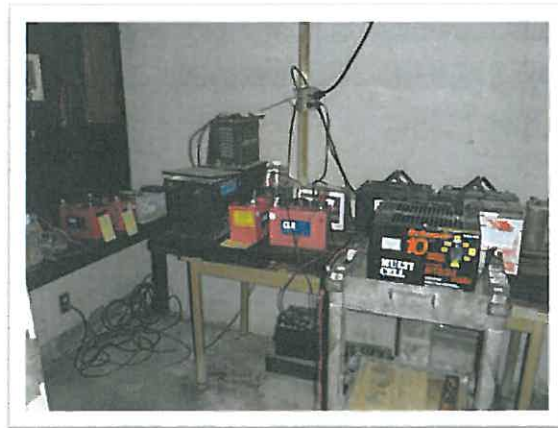
In a few locations, it appeared additional 120V, 20 amp duplex receptacles are needed to meet the needs of the end users. In these locations, the school should consider adding additional receptacles. See picture below.

Additional receptacles needed.

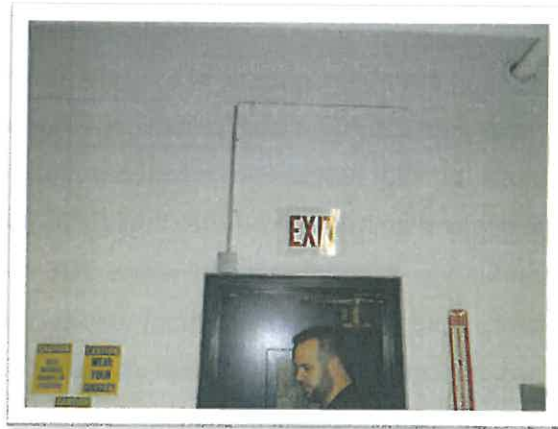
In general lighting is utilitarian and appropriate for the use of the space. One item to note, many of the areas do not have internally lit or self-illuminated exit signs. In the event of a power loss, the signs will not be seen. The existing non-lit exit signs should be replaced with either internally lit or self-illuminated exit signs.

Exit sign should be replaced

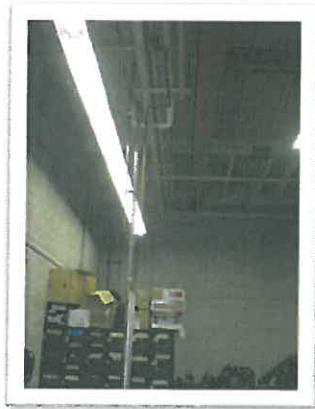
Record drawings indicate the water service entered the Tech Building from College Drive. It was noted as a 3" service. The size of the service appears adequate in supplying the demand of the fixtures within the building. The pipe material used in the building appear to be painted galvanized piping for the most part with a combination of copper piping in areas that showed signs of alteration (Refer to Fig. 1 & 2). It may have been a part of the original construction which dates back to 1964. The average life expectancy of galvanized pipe is typically anywhere from 40 to 50 years and can be less depending on the characteristics of the water in the area. The pipes could presumably be at the end of its expected life. Further evaluation can be performed by taking a sample of the pipe and examining the interior surface for corrosion and/or sediment build-up.

Fig 1 - Galvanized water pipe

- Record drawings noted a 3" domestic water service to the building. The 3" service appears adequate in size to serve the existing fixture demand of the building. The pipe material used within the building appear to be galvanized piping for the most part with a combination of copper piping in areas that showed signs of alteration. The average life expectancy of galvanized pipe is typically anywhere from 40 to 50 years and can be less depending on the characteristics of the water in the area. Assuming galvanized piping was a part of the original construction which dates back to 1964, the pipes could presumably be at the end of its expected life. A consideration in repiping with copper material is highly recommended.

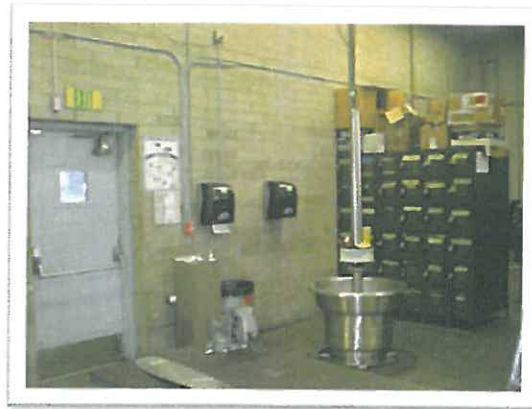
Fig 2 - Galvanized water pipe to electric water cooler.

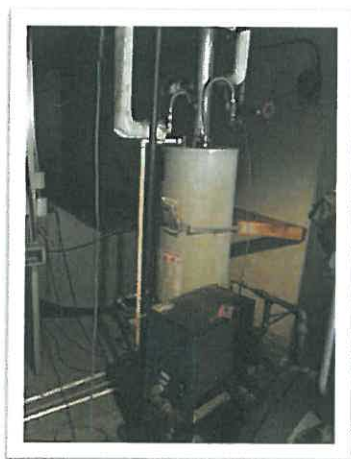
There was an existing gas-fired tank type water heater located in a mechanical room of the mezzanine level (refer to Fig. 3 & 4). It is not seismically secured per 2010 CPC, Section 508.2. Strapping shall be at points within the upper 1/3 and lower 1/3 of its vertical dimensions. The system has a hot water return loop and possibly supplying the existing stainless steel wash fountains in the Aeronautics Lab (114) and Auto Shop (116). There were no available record drawings to confirm the extent of hot water distribution. The water heater may have to be replaced with a bigger unit to accommodate the tepid water requirement for the emergency equipment. The hot water for the lavatories in the restrooms are provided by a point-of-use instantaneous water heater (refer to Fig. 5 & 6). The heaters are in good working condition.

Figure 3 - Water heater at mezzanine level

- The existing gas-fired tank type water heater located in the mezzanine level will have to be replaced with a larger unit to support the added demand required by the safety/emergency equipment for delivery of "tepid water". The water heater shall also be seismically secured and provided with a drain pan per current codes and standards.

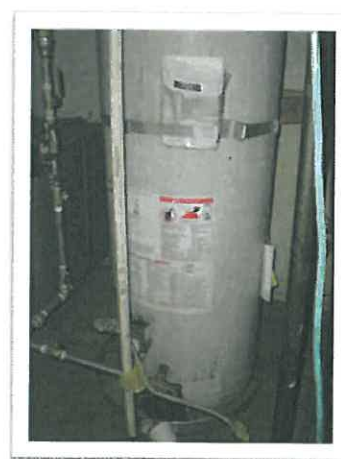
Figure 4 - Improper strapping of water heater

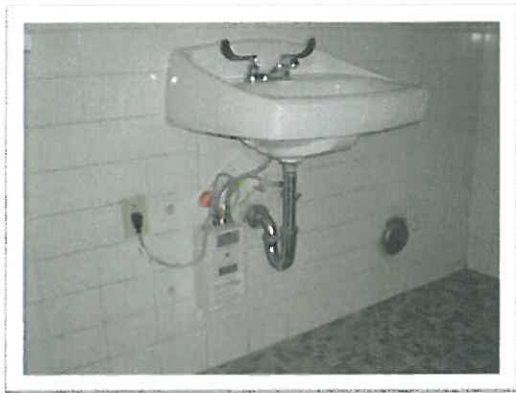
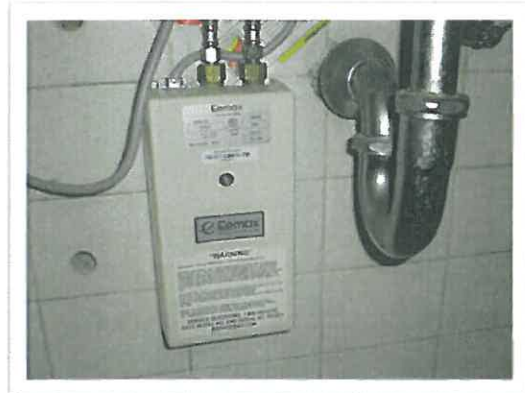
Fig 5 - Insta-hot water heater

Fig 6 - Insta-hot water heater

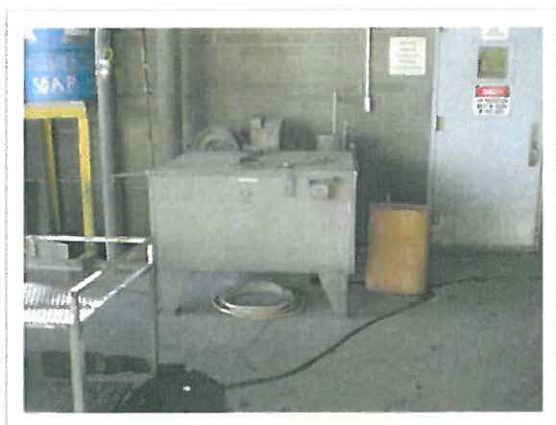
Fig 7 - Boil out tank for washing parts.

The drain discharge from the equipment (transmission washer and boil out tank) in the Steam Clean area sheet flows into the existing sump drain. A faculty member said the quality of the waste discharged from the equipment was non-hazardous. We were also informed the transmission washer has not been used for the past 2 to 3 years. However, the boil out tank is used regularly to wash parts. Wastewater sheet flowing on the surface will produce mildew in due time if not cleaned and dried. It will create an unsafe condition for students and staff working in the area. We recommend providing a dedicated floor receptor for each equipment and be located adjacent to the equipment or extend the drain pipe of the equipment and terminate with an air gap above the sump drain.

- The existing transmission washer and boil out tank in the Steam Clean Area have drain connections which discharges on the floor surface when in use thus creating an unsafe condition. We recommend the provision of floor receptors placed adjacent to the equipment. Extend and connect the receptor drain piping in the inlet side of the existing interceptor. Another viable solution is to extend the equipment drain to terminate above the sump drain with an approved air gap.

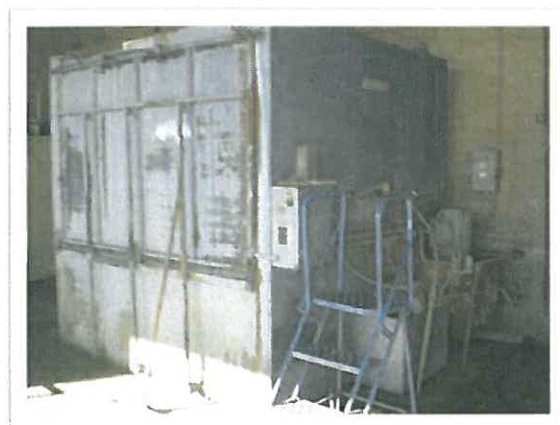
Fig 8 - Transmission washer in  
Steam Clean area

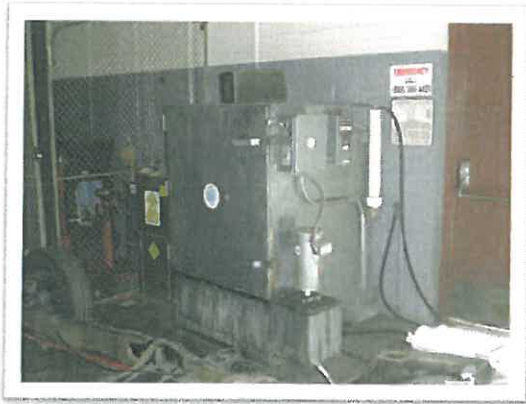
Fig 9 - Transmission washer in Auto Shop

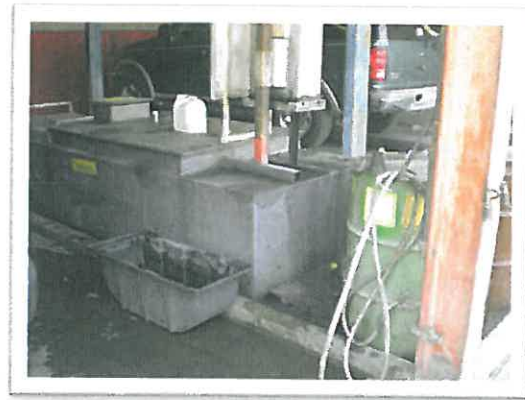
The existing hose bibs throughout the buildings are in fair condition but were not equipped with any form of backflow prevention devices. A number of them are used to supply the water inlets of equipment, i.e. the transmission washer and the boil out tank in the Steam Clean Area, and the transmission washer in the Auto Shop (116). (Refer to Fig. 7, 8, & 9). There were several hose bibs without a backflow device that had garden hose connections exposed to possible back siphonage (refer to Fig. 10). These conditions are in violation of Section 602 and 603 of the CPC. The water supply for the safety/emergency equipment were also not provided with a backflow device. It is good engineering practice to install a check valve upstream of the supply connection to prevent possible back siphonage of contaminated water (refer to Fig. 11 & 12).

Fig 10 - Hose bib without vacuum breaker with hose laying on wetted pavement.

- Existing wall hydrants/hose bibs without backflow prevention measures were found throughout the building. They appear to be part of the original construction. We recommend replacing them with new hose bibs equipped with a vacuum breaker to prevent back siphonage and cross contamination.

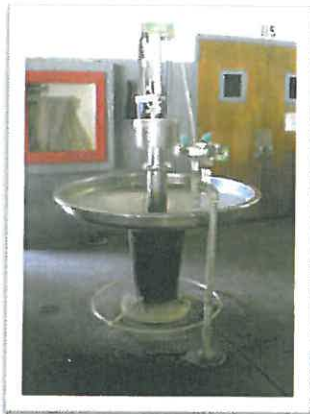
Fig 11 - No backflow or check valve on water supply of eyewash.

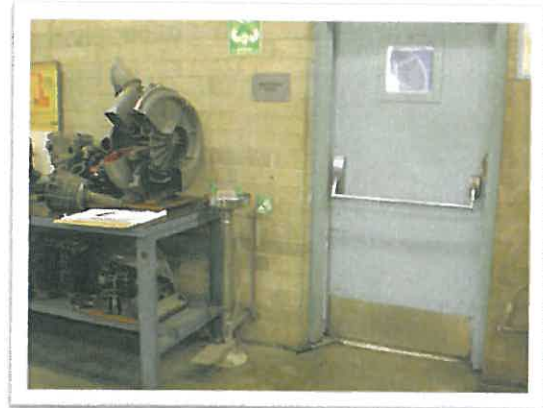
Fig 12 - Galvanized pipe supply with no backflow or check valve.

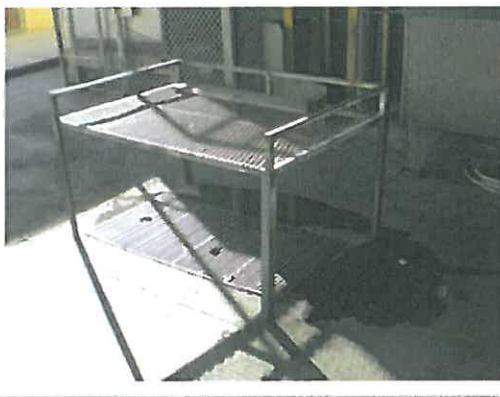
A sump drain and a sediment interceptor was seen in the Steam Clean area between the Auto Shop and Aeronautics Lab (refer to Fig. 13 & 14). The sump drain receives the drain run-offs from the transmission washer, boil out tank, and the steam generator. There are no record drawings to determine the manner in how the sump drain and sediment interceptor is connected to the building drain system. The underground piping would need to be located and traced. Both the sump drain and interceptor would need to be maintained periodically. Efficiency of operation is directly related to the level of maintenance.

Fig 13 - Sump drain in Steam Clean area.

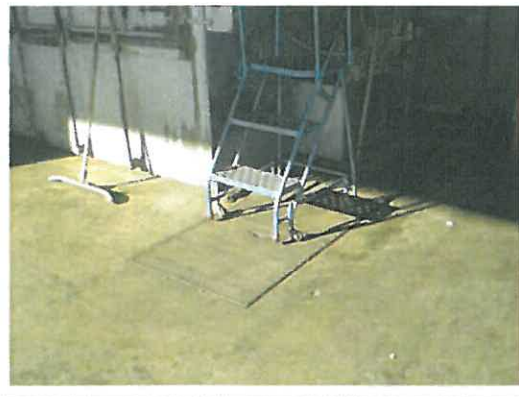
Fig 14 - Sediment Interceptor

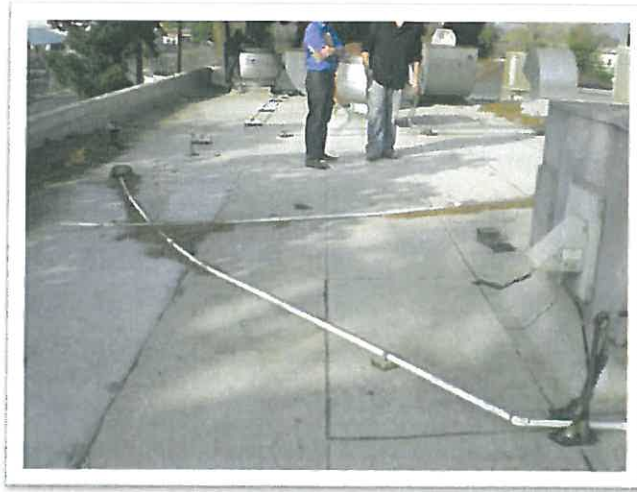
Fig 15 - PVC condensate drain pipe without adequate supports.

A combination of copper and PVC tubing were used for the condensate drain piping of the existing rooftop air conditioning units. They are in poor condition and installed without pipe supports (refer to Fig. 15). For condensate pipes with supports, wood blockings with pipe straps were used but none of which were secured to the roof. There were several drains without a p-trap assembly (refer to Fig. 16). Condensate drains were also terminating into a roof drain (refer to Fig. 17). We recommend replacing all the condensate piping with new copper tubing and install per current codes and standards

- Condensate drain piping of existing rooftop A/C units will have to be replaced with new piping and pipe supports as the conditions and installation of the existing drain piping are in violation of current codes and standards.

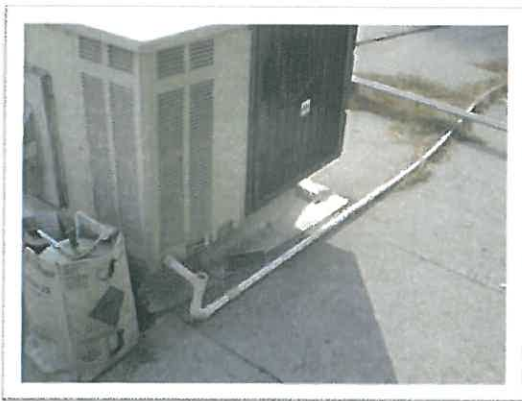
Fig 16 - Condensate drain without p-trap assembly.

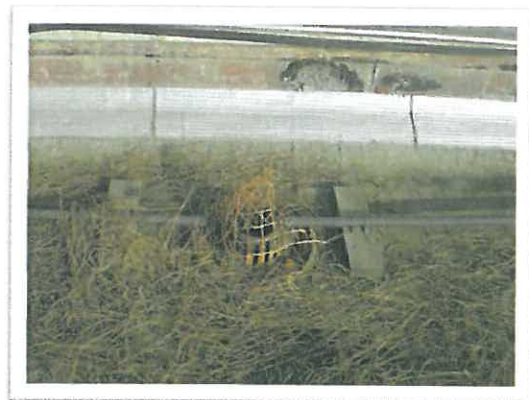
Fig 17 - Condensate drains terminating at a roof drain.

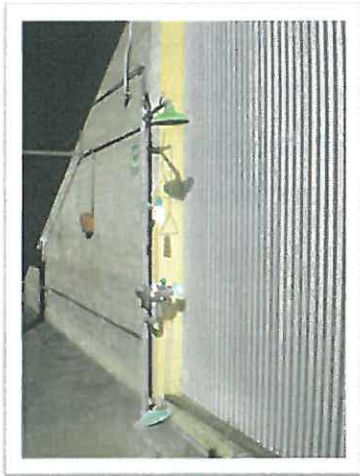
A total of 5 emergency eye/face wash and 1 combination eye wash/drench shower were found in the building. Emergency eye/face wash stations were located in rooms 110 (Front Welding), T111A (Machine Shop), 116 (Auto Shop), 114 (Aeronautics Lab), and at the exterior of the Shop Building adjacent to room 119 (Welding Classroom). A combination eye/face wash and drench shower was located in the Steam Clean area by the service yard. They were all examined and found to be in operating condition. However, all the stations were in fair to poor physical condition. Some of the components are showing signs of damage, i.e. the retainer straps that keeps the dust covers in place on the eyewash heads are missing, the foot control assembly on some of the stations show wear and tear. There were obstructions around the location of the emergency equipment that could possibly hinder the path of travel and its use. The water supply line for the combination eyewash drench shower appears to be undersized. Refer to figs. 18, 19, 20, 21, 22, & 23.

Fig 18 - Steam Clean Area – undersized water supply line.

We recommend replacing the existing emergency equipment with new in kind. Locations of stations and installation shall be re-assessed to meet ADA, ANSI and Cal OSHA standards.

- All water supply lines must be provided to meet the ANSI minimum flow requirements at 30-90 psi. The recommended incoming pipe sizes are as follows:
  - a. ½" IPS for eyewash stations and eye/face wash stations
  - b. 1" IPS for drench showers
  - c. 1 ¼" IPS for combination eyewash drench showers
- A "tepid water" temperature shall be delivered to the flushing stations. ANSI defines "tepid water" as a flushing fluid temperature conducive to promoting a minimum of 15 minute irrigation period. A suitable range is 60-100 deg. F. Tepid water can be delivered by installing a thermostatic mixing valve to blend the hot and cold water service.
- Proper maintenance and weekly testing per ANSI standard shall be implemented by the facility to ensure flushing stations are functioning safely and properly.

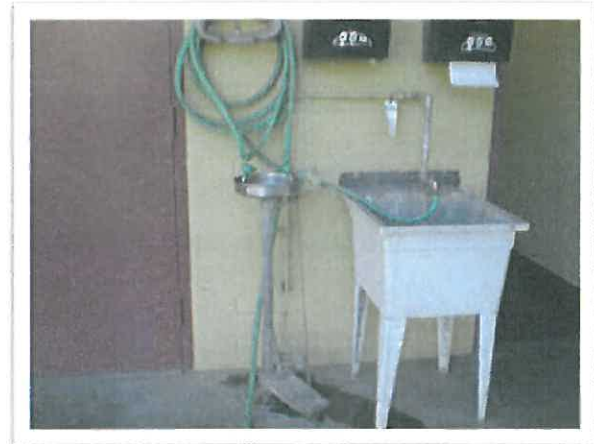
Fig 19 - Shop Building – obstruction around emergency equipment.

- All safety/emergency equipment installed must be clearly identified with a highly visible safety sign.
- Proposed locations shall have an unobstructed path of travel and within 10 seconds (approximately 55 feet) of hazards.

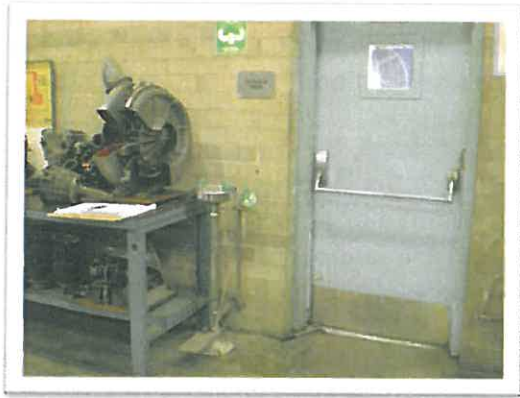
Fig 20 - Aeronautics Lab – obstruction around emergency equipment.

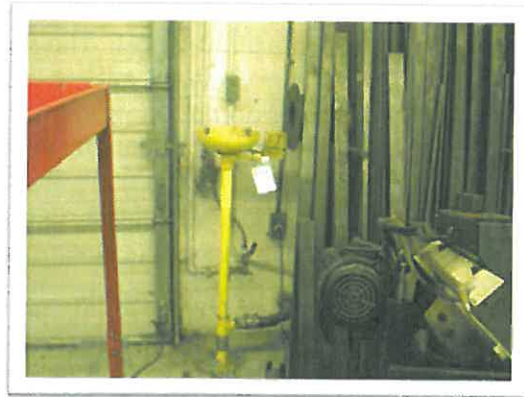
Fig 21 - Machine Shop – obstruction around emergency equipment and near electrical receptacle.

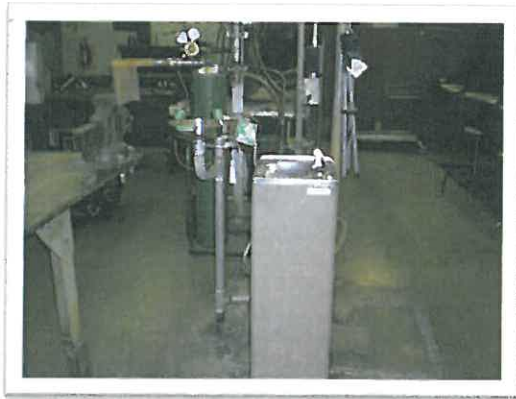
Fig 22 - Front Welding Room – poor location of emergency equipment.

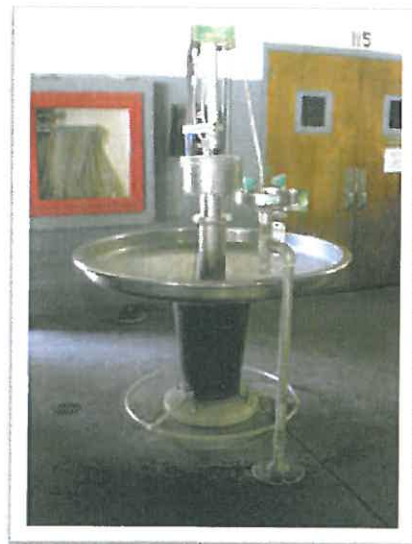
Fig 23 - Auto Shop – poor configuration of emergency equipment.

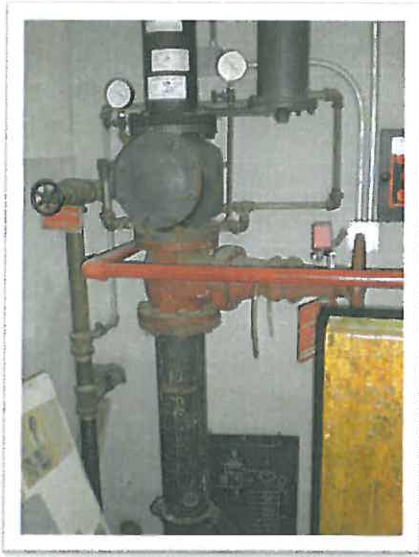
The Tech Building is protected by an automatic wet-pipe fire sprinkler system. There are two (2) fire sprinkler risers (a 6" and an 8" respectively) located in the south end of room 114 (Aeronautics Lab). Refer to Fig. 24 & 25. Record drawings indicated the total building area is 57,531 sq.ft. The maximum system protection area for a single sprinkler system riser is 52,000 sq. ft. thereby requiring two risers. The 6" riser provided the sprinkler system for the typical classrooms, corridors, and restrooms which are located within the west half of the building. The 8" riser supplied the sprinkler system for the east half of the building (Aeronautics Lab and Auto Shop). The sprinkler risers and distribution piping appear to be in good condition. However the system shall be periodically inspected, tested, and maintained per frequency noted in NFPA 25. Fire extinguishers were also provided throughout the building. Inspection tags are all current. Upright sprinkler heads were provided in areas without ceiling; pendent sprinkler heads with escutcheons in areas with ceiling (refer to Fig. 26). They are of the fusible link type and appear to be in good condition without signs of damage. Auto Shop (117) and the Shop Building east of the service yard did not have any fire sprinkler coverage. However, fire extinguishers were provided in each room and their inspection tags are all current. We recommend extending the sprinkler coverage of the 8" fire riser to include Auto Shop (117).

Fig 24 - Aeronautics Lab - 6" fire riser

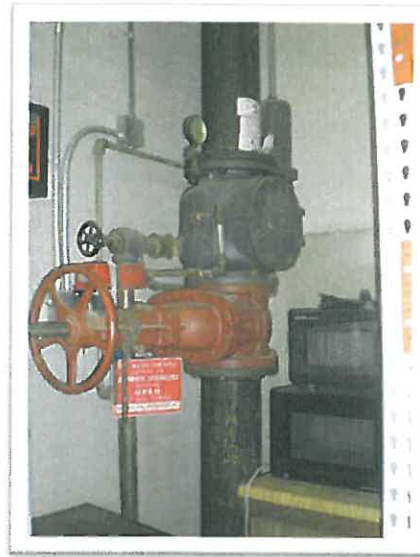
Fig 25 - Aeronautics Lab – 8" fire riser

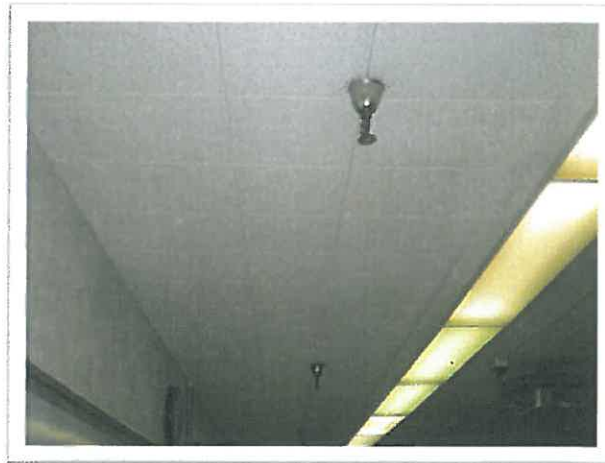
- Fire extinguishers were also provided throughout the building. Inspection tags are all current.
- Upright sprinkler heads were provided in areas without ceiling; pendent sprinkler heads with escutcheons in areas with ceiling. They are of the fusible link type and appear to be in good condition without signs of damage.

Fig 26 - Typical pendent sprinkler head

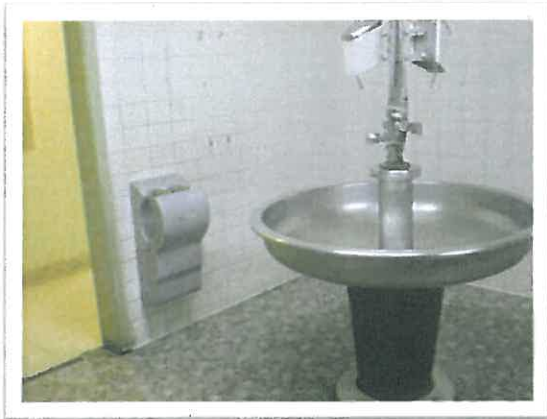
fountain with hot and cold water supply (refer to Fig. 27) and a wall mounted lavatory with a single temp (cold water only) faucet (refer to Fig. 28).

Fig 27 - Wash fountain in Men's restroom

In general the plumbing fixtures throughout the building (Tech and Shop building) are in working but fair condition. However, we recommend replacing them with new high-efficiency, low-flow fixtures to reduce energy and water consumption and to comply with codes and standards.

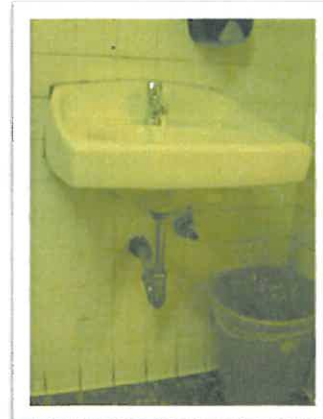
Fig 28 - Single temp lavatory at Men's restroom

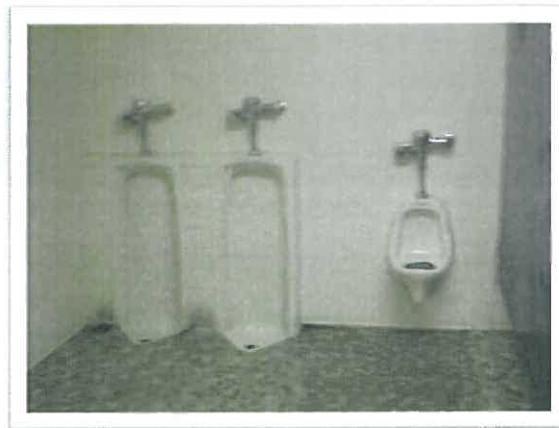
Fig 29 - Urinals at Men's restroom
