PROPERTY & LIABILITY INSPECTION

January 2012

**PREPARED FOR
San Bernardino Community College**

KEENAN & ASSOCIATES
3550 Vine St. Suite 200
Riverside Ca. 92507

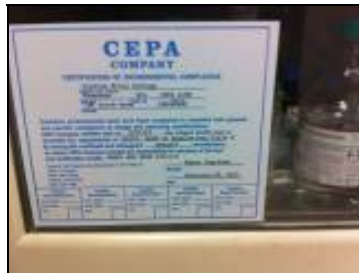
LADM 102 Storeroom

2. A container marked 'Radioactive' is located in the storeroom cabinet. This item needs to be tested and disposed of accordingly.
